racing imminent collapse when

acquired in early 2018 by the Route

66 Co-Op, a U.S. Park Service grant with contracting and preservation and other fundraising efforts allowed experience, along with other relevant stabilization work of the trading post skill sets, but no one involved had attempted such a challenge. The budget discouraged hiring the work done, recades of soil erosion, wind, and but networking led to other preservawater had opened the roof and tionists who had made careers of savcaused the walls to sag from a dising similarly distressed landmarks. integrating foundation, which was Consultations with them generated the nothing more than a concrete curb knowledge needed to produce both sitting on the ground. Roof rafters were confidence and a plan, although rotted, and exterior walls had been improvisation proved to be a daily damaged by cattle. The site's remote ingredient once work got underway. location created logistical challenges, requiring that a generator and water With few exceptions, the rescue was completed by a spirited crew of allbe brought in, and that equipment and materials be transported from volunteer labor, and a successful Albuquerque and Gallup, Ne

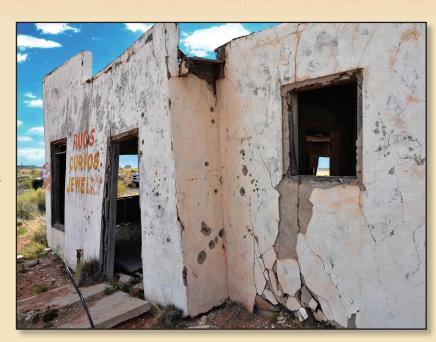
The wavy east wall was pushed out of shape by the collapse of the foundation.

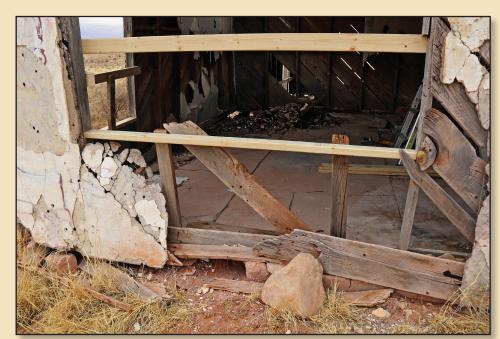
Cattle had completely destroyed the wall beneath the west front window.

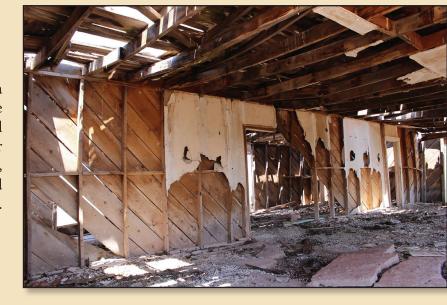
For half a century the interior had been a shelter for livestock, crows, and other animals.

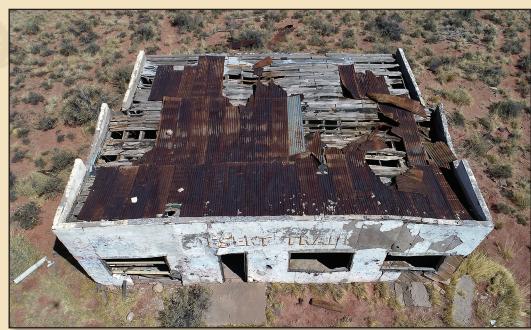
The building's roof sagged from decades of unchecked wind, rain and snow.

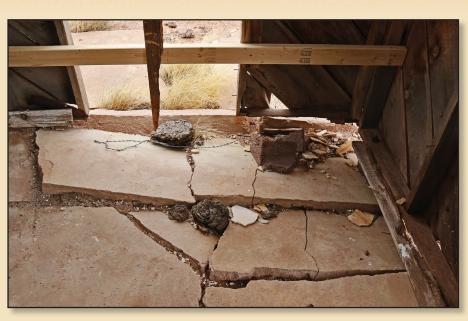
Interior view of the northwest corner, where erosion below the slab caused it to break under the weight of livestock.

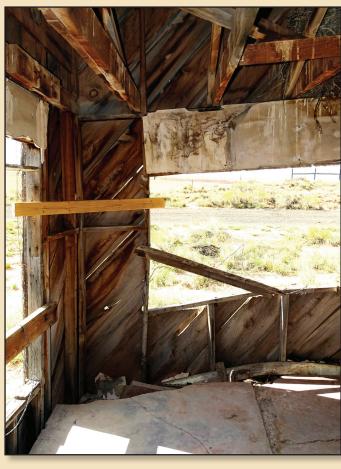
The southeast corner had slumped a full sixteen inches from the level of the slab floor, creating a serious threat to the structure's stability.

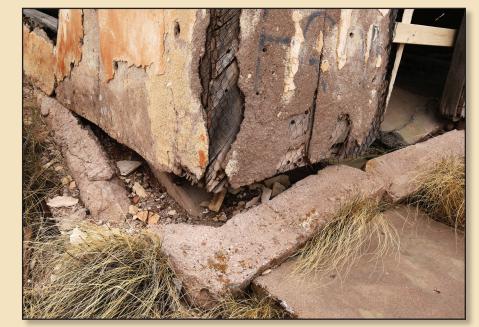
The foundation had completely fallen away from the building's northwest corner.
