PAINTED DESERT TRADING POST NPS GRANT COMPLETION REPORT (Compiled June 2019)

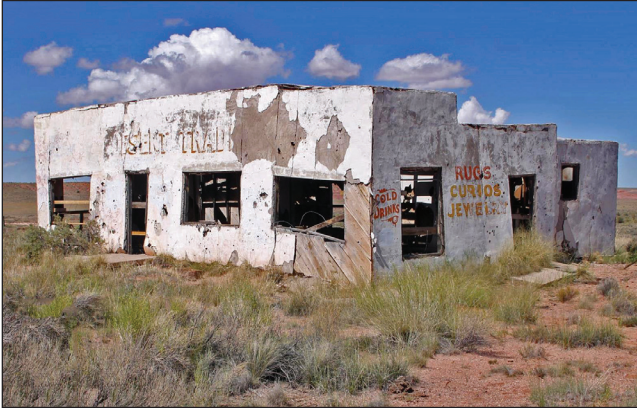
View of front and east walls. Lisa Drewitz

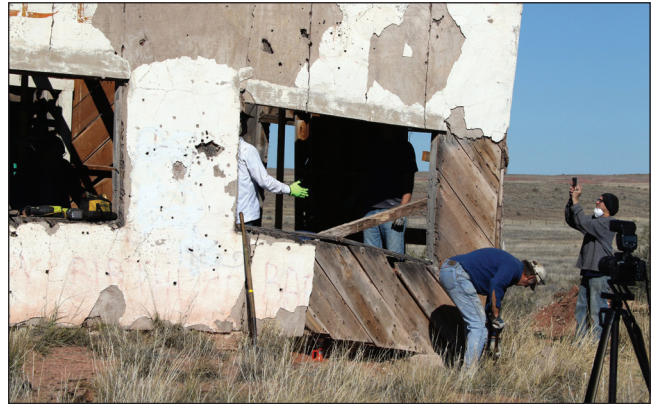
East end of front wall.

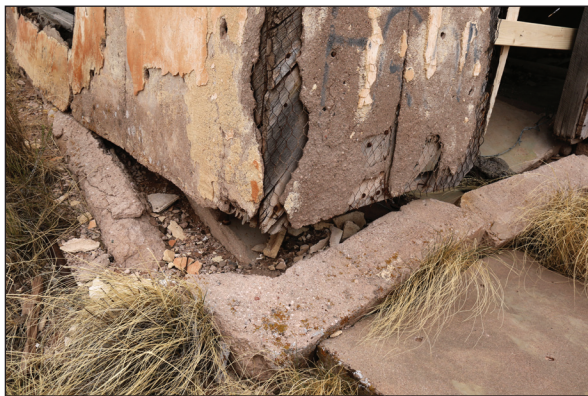
As mentioned, the foundation was heavily compromised. Only parts of it along the rear wall and in the area around the front door were relatively intact. The roof had lost nearly half of its sheet metal, and the roof decking was either missing or rotted, allowing water damage to occur, seriously degrading the roof rafters and ceiling joists. Similarly, the sill plates (base plates) of the walls had long been exposed to the elements due to the failed foundation and stucco loss, rotting them, as well as many of the wall studs resting on them. In some areas, sill plates and wall studs were completely gone from the foundation to a point several inches up the wall. An initial assessment, conducted in April 2018, concluded that collapse of the structure was imminent.

Foundation at NW corner.

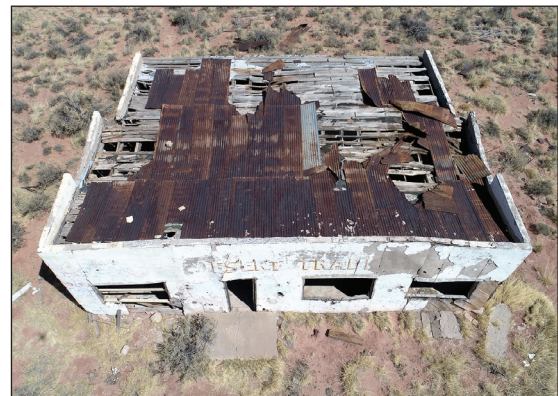
Condition of roof.

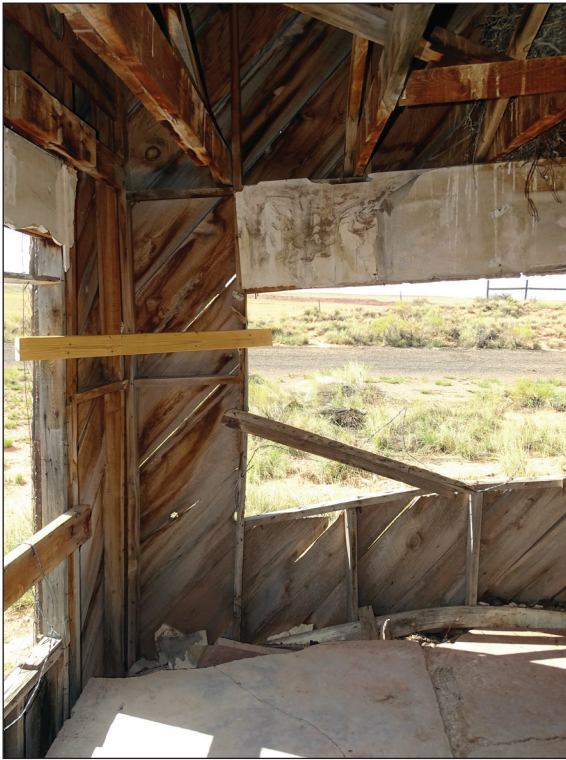
View of SE corner (camera facing south). NPS

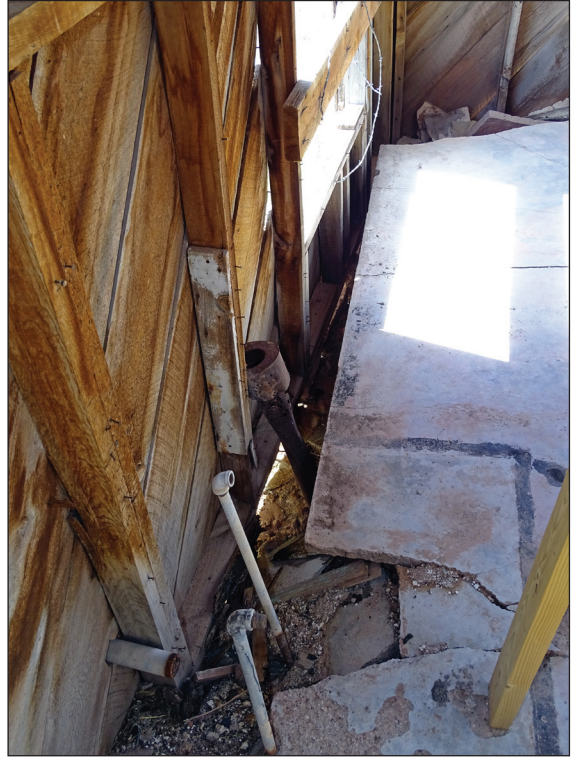
East Wall (view toward front) illustrating fallen wall due to foundation failure. NPS

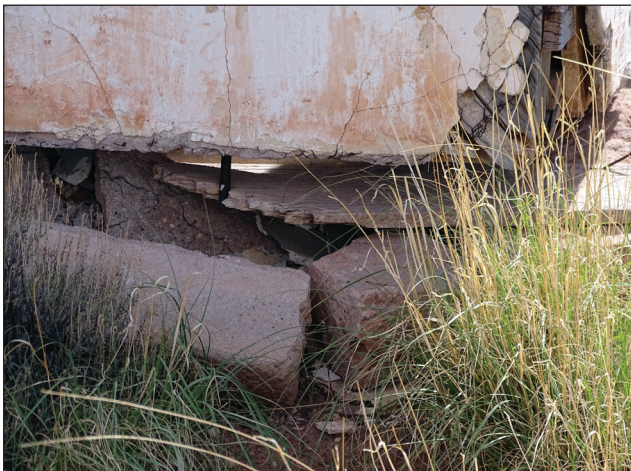
Foundation and sill plate separated from wall. NPS

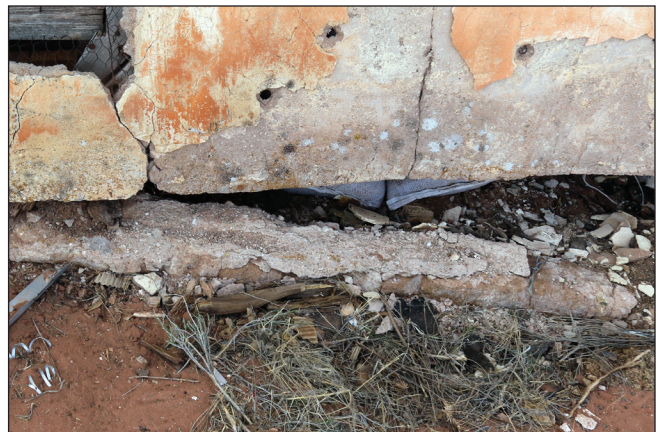
Collapsed foundation.

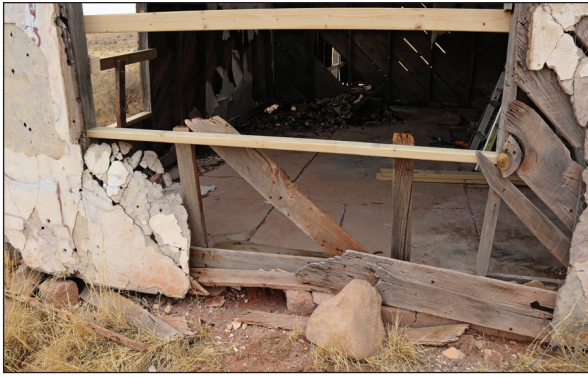
Cattle damage - west front window.

Compounding the deterioration, cattle from the surrounding ranch had damaged the stucco facade in multiple locations and had completely destroyed the front wall beneath the west front window. Virtually all of the drywall on the inside walls, long subjected to rain and snow, had fallen from the walls and ceilings, and was subsequently pulverized by the cattle. Additionally, crows nests, as well as rodent nests, were in evidence. The result was a heavy accumulation of granulated dry-wall mixed with cattle excrement and crow droppings covering large portions of the floor throughout.

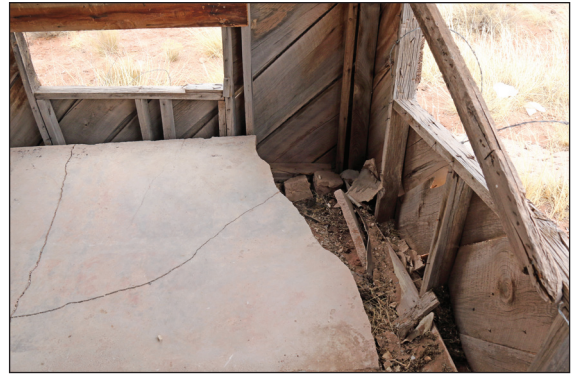
SE corner resting on ground 16" below the floor.

Once the building was cleaned out, wall raising began, using an already developed strategy. The four corners of the building had previously been prioritized based on severity of elevation loss. Worst was the southeast corner on the building's front, which had fallen 16" from the level of the concrete slab floor. The opposite (southwest) corner was similarly compromised, having dropped approximately 10." The two back corners (northeast and northwest) showed only minor displacement, with the northwest corner being worse than the other.

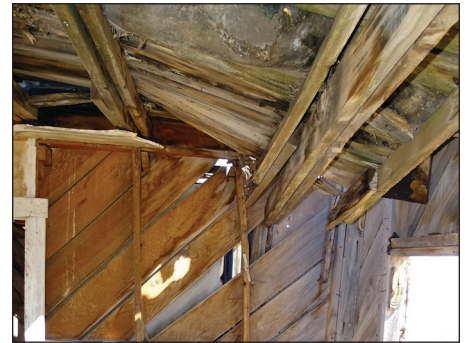
Roof collapse at east end of partition wall. NPS

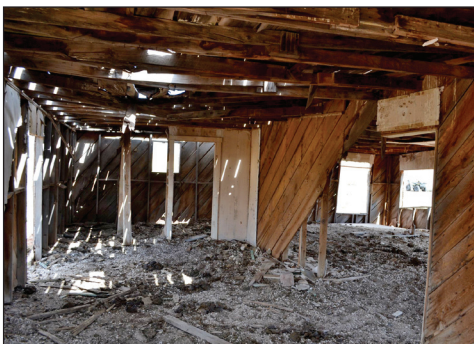
Debris covering the floor.

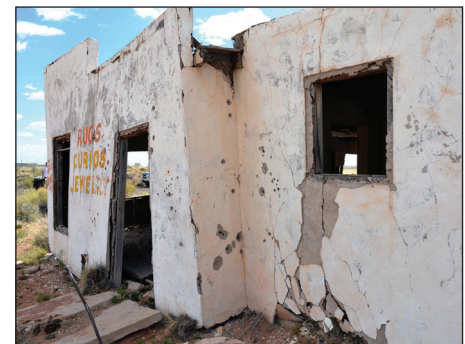
Bottom of wall pushed away from building (near door opening); cattle damage to stucco.

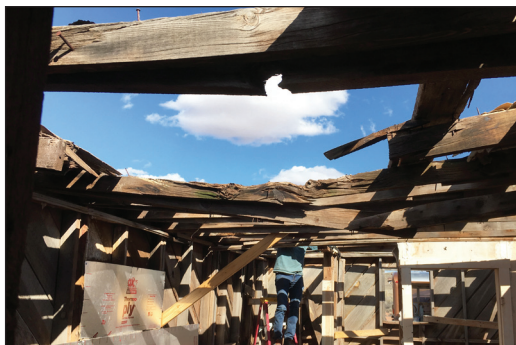
Rotted ceiling in rear room.

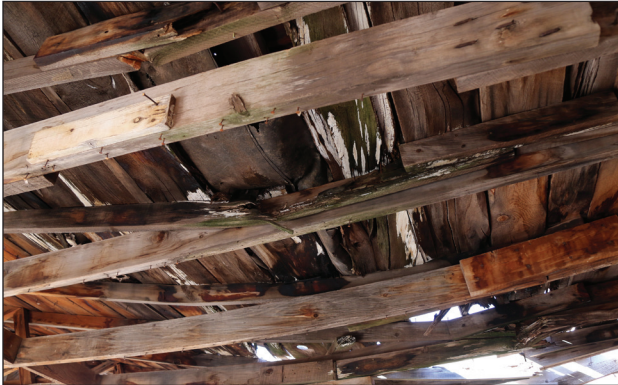
Condition of existing rafters and joists at the east end of the front room.
