## Rescue PHASE 1

(NOVEMBER 4-11, 2018)

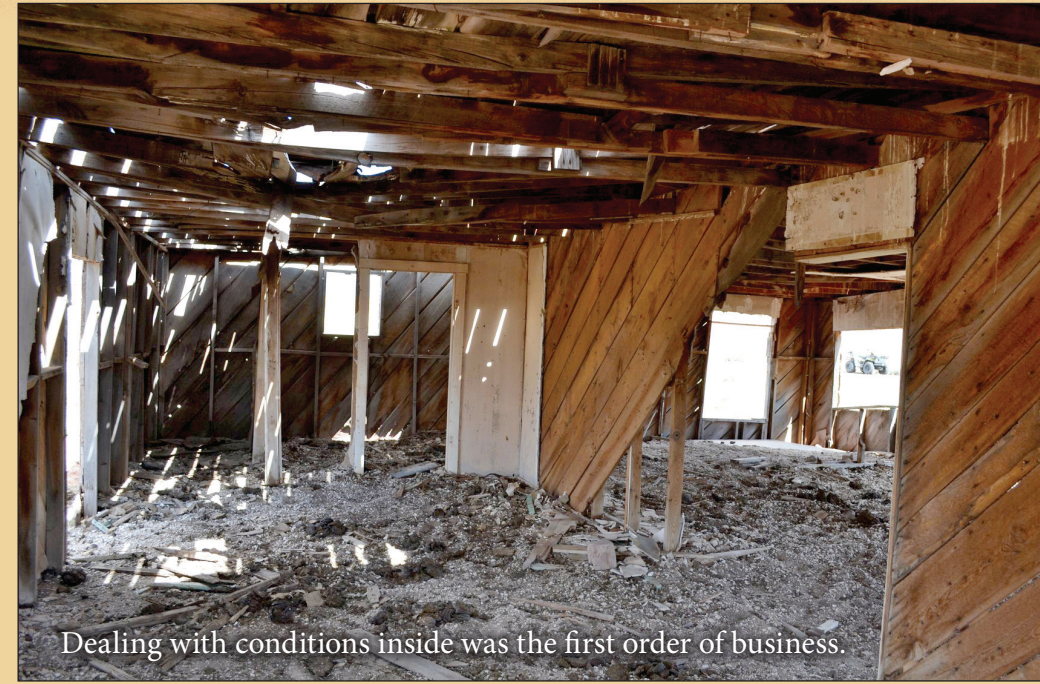
Dealing with conditions inside was the first order of business.

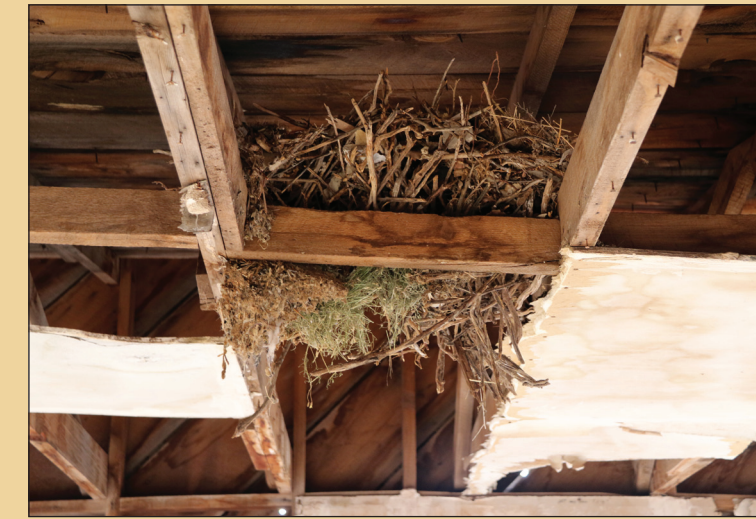
Several large nests like this one were removed as angry crows circled the building.

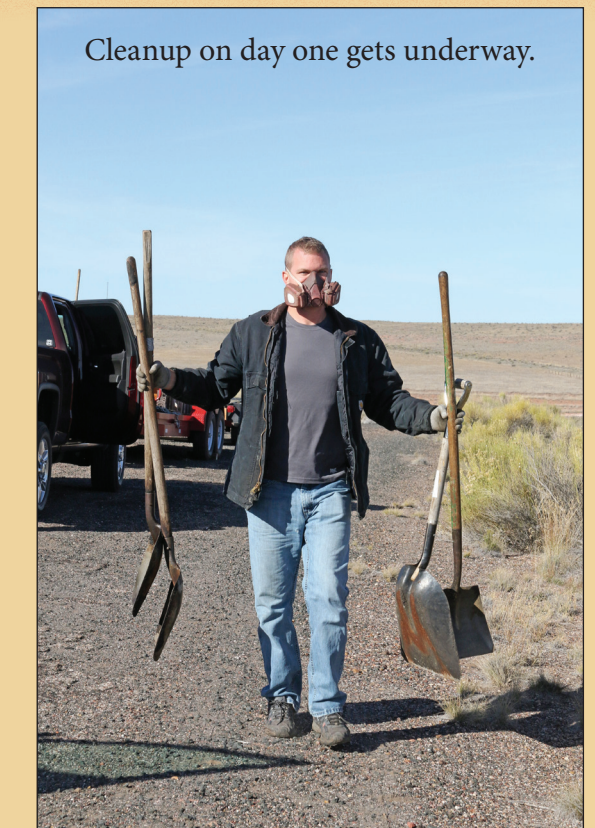
Cleanup on day one gets underway.

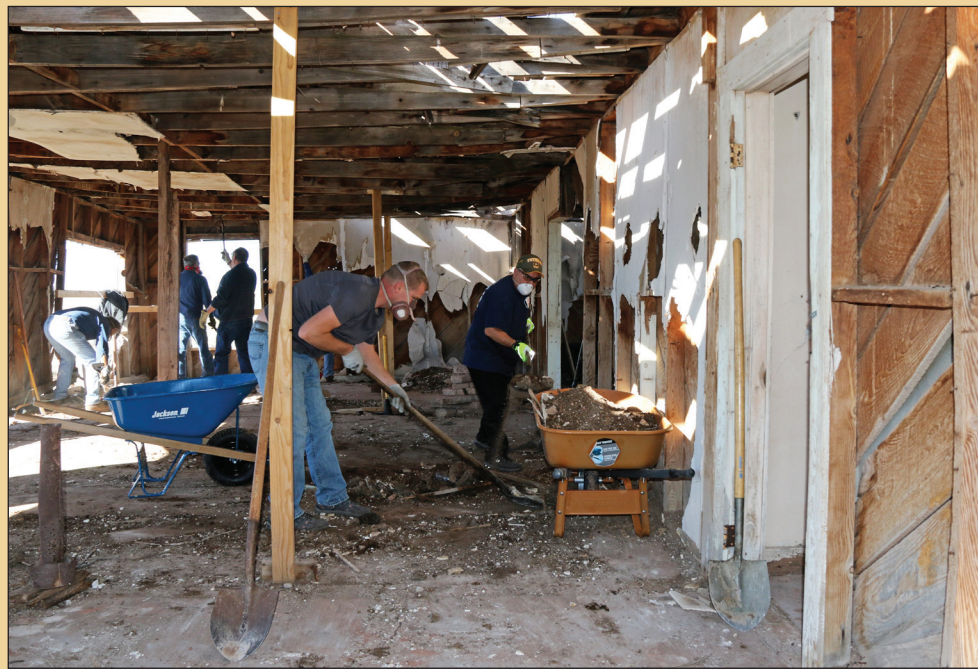
Clearing the debris and removing old sheetrock took a full day.

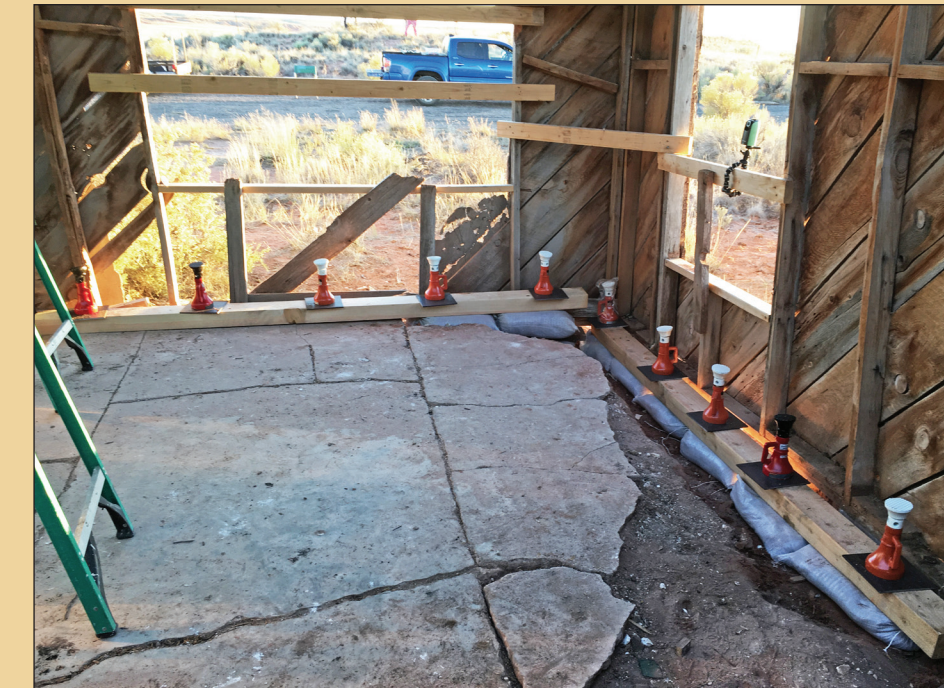
Sandbags and timbers created a stable platform for raising walls.

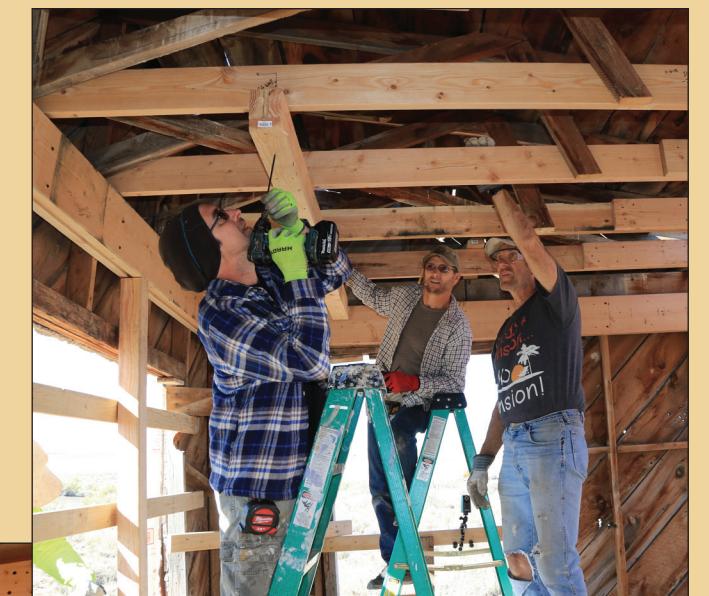
Crew members install a beam in preparation for raising the building's southwest corner.

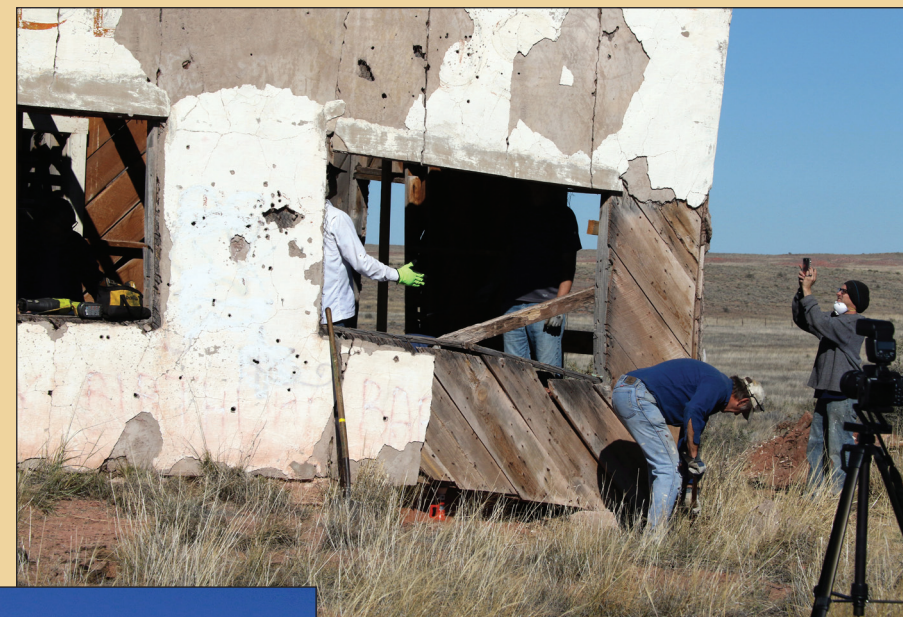
A screw jack is placed under the dangerously sagging southeast corner to provide temporary support.

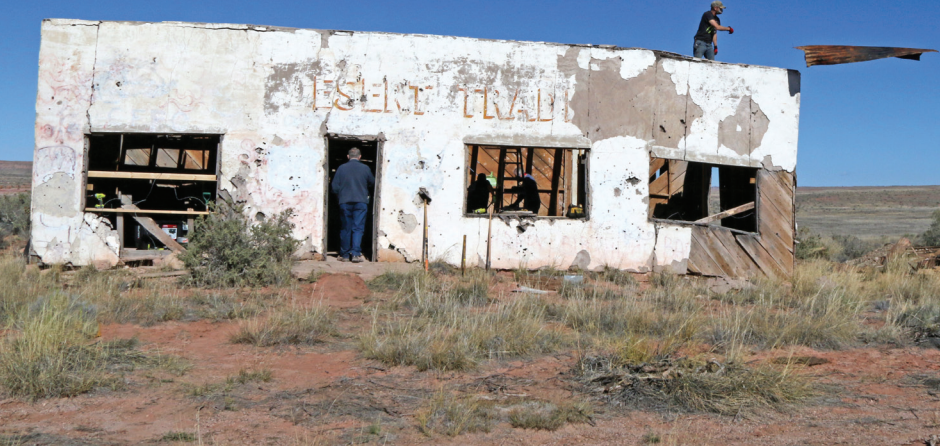
Once correct elevation was obtained, shear walls were built thirty inches inside existing exterior walls to hold the repositioned building in place.

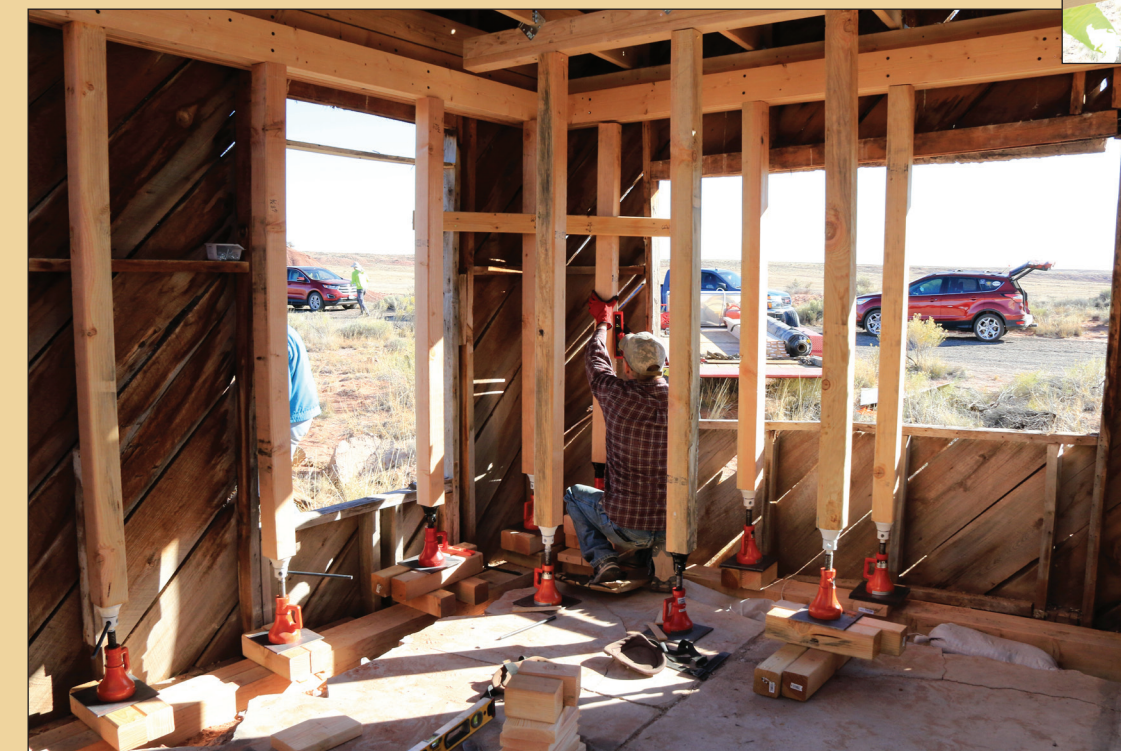
A crew member uses a level on a jack post. If even slightly off, the screw jack beneath the post could roll over under the building's weight.

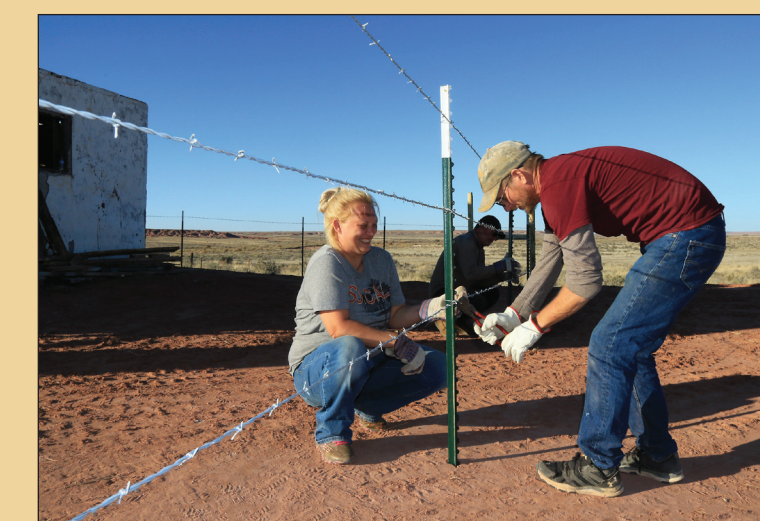
Because the trading post is surrounded by a ranch, a fence was needed to keep cattle away from the building.

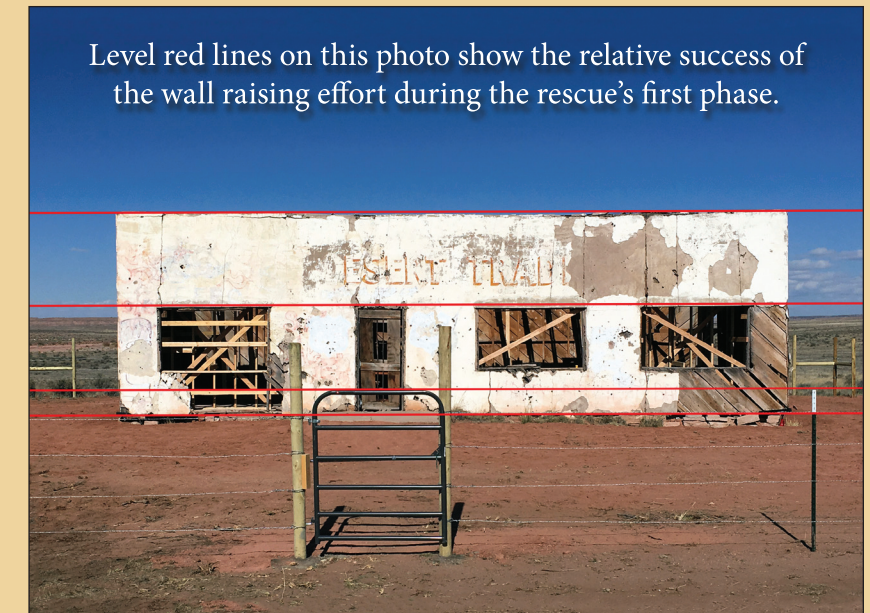
Level red lines on this photo show the relative success of the wall raising effort during the rescue's first phase.
