Rescue PHASE 2

(MARCH 16-22, 2019)

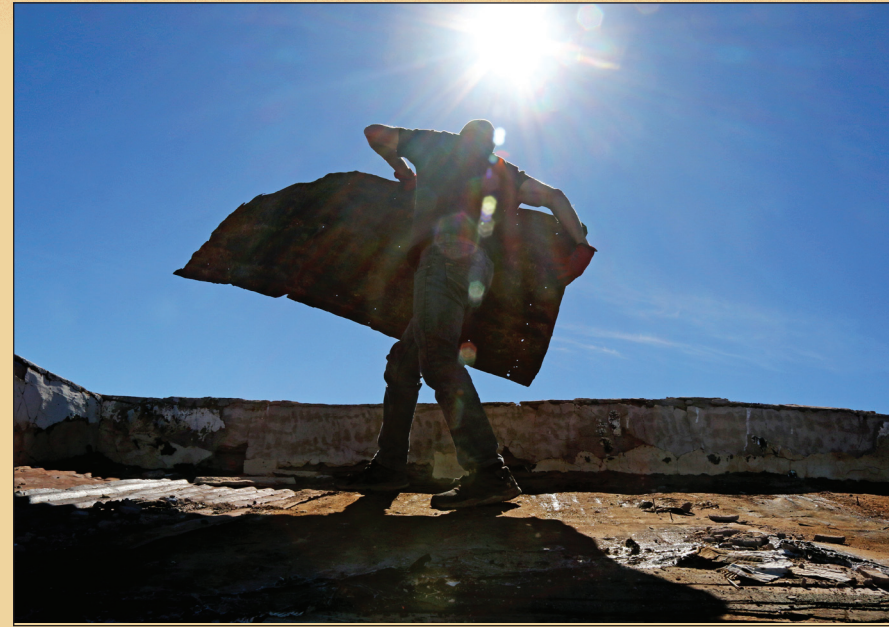
Remaining sheet metal comes off the roof at the beginning of the second work session.

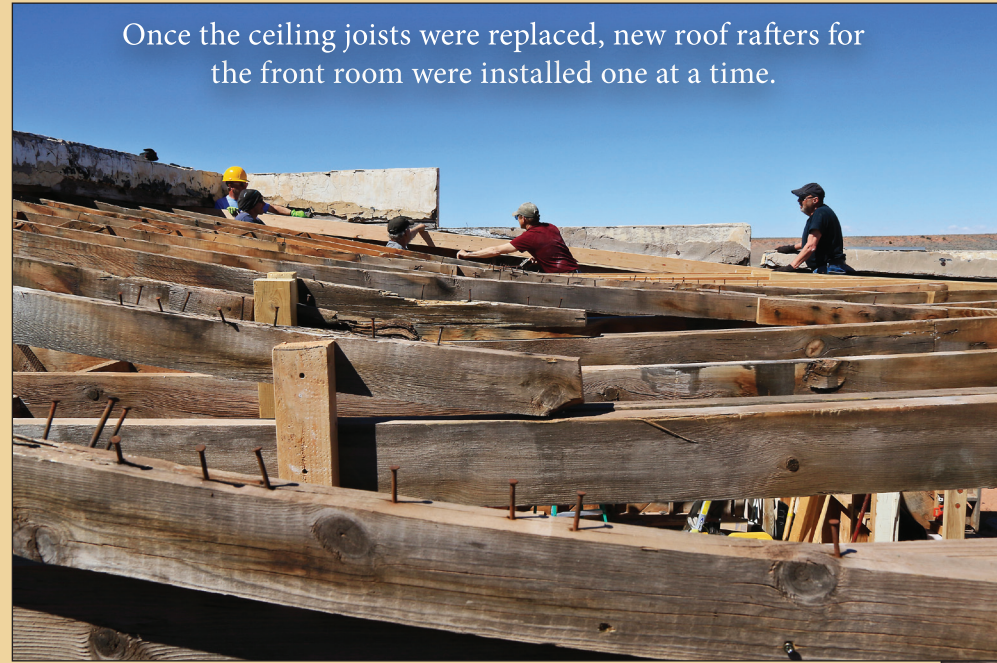
Once the ceiling joists were replaced, new roof rafters for the front room were installed one at a time.

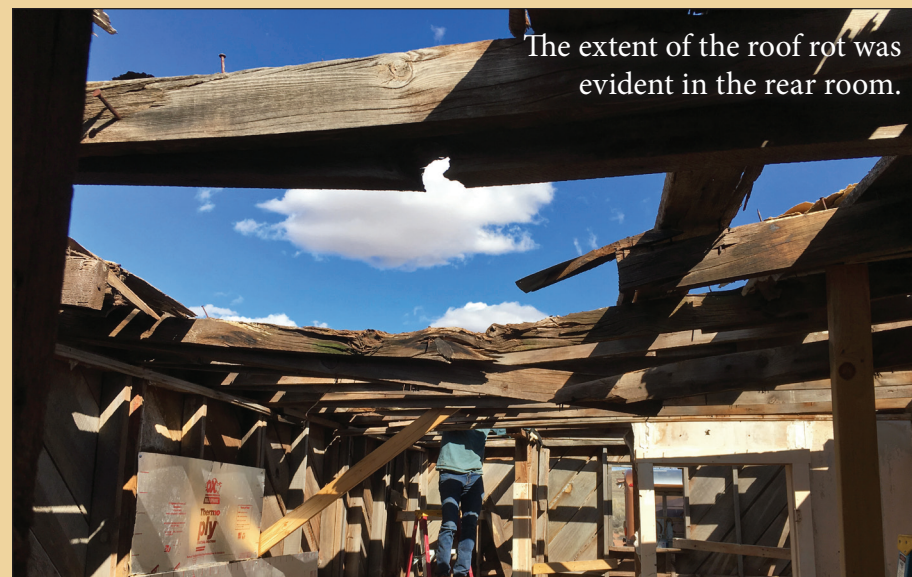
The instability of the roof required that ladders be used to remove the old decking.

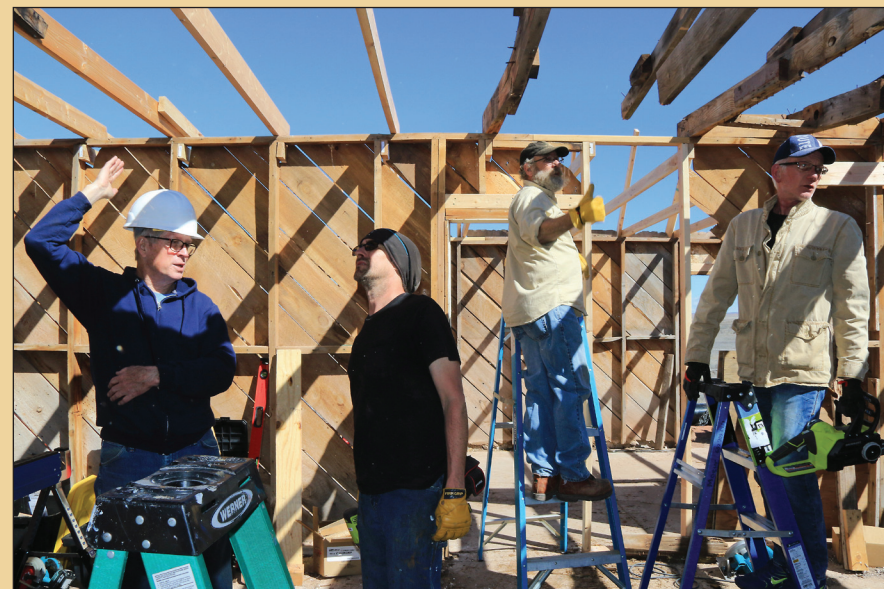
The extent of the roof rot was evident in the rear room.

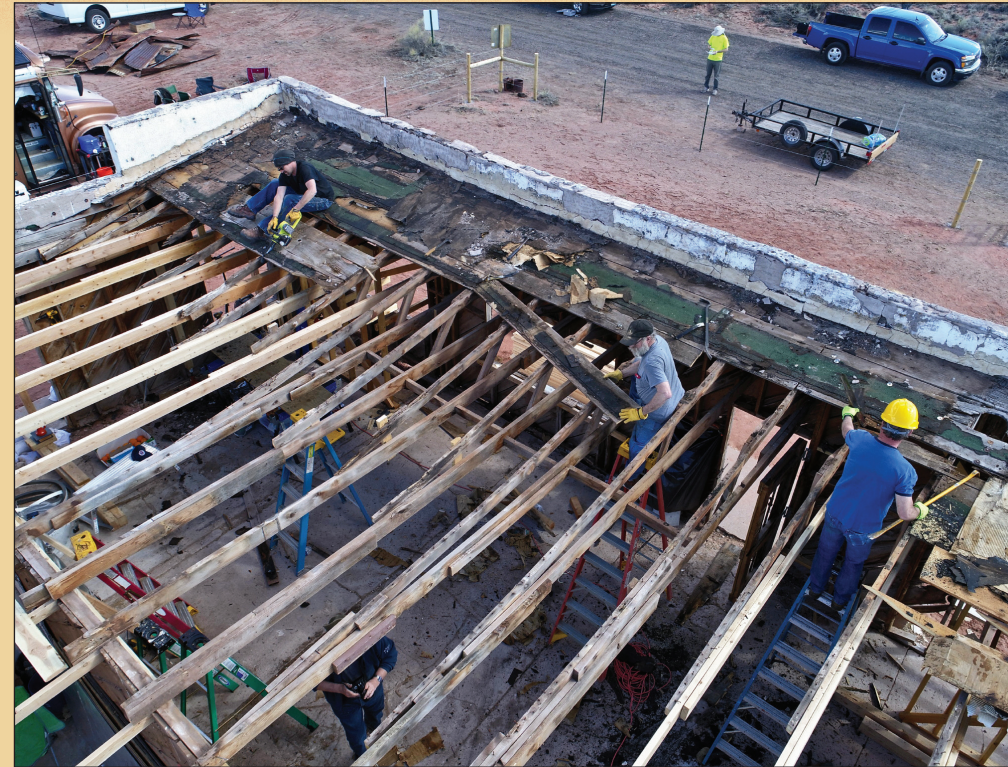
New ceiling joists replace the old in the back room.

Roof replacement began with complete removal of the tattered sheet metal, underlying paper, and wood decking. At the same time, ceiling joists were replaced one by one. Fortunately, seven of the original joists retained enough integrity to be saved and incorporated with the new roof structure. Once this was completed, the rest of the roof was removed, with care taken to save portions of existing rafters and most of the original bracing between rafters and ceiling joists.

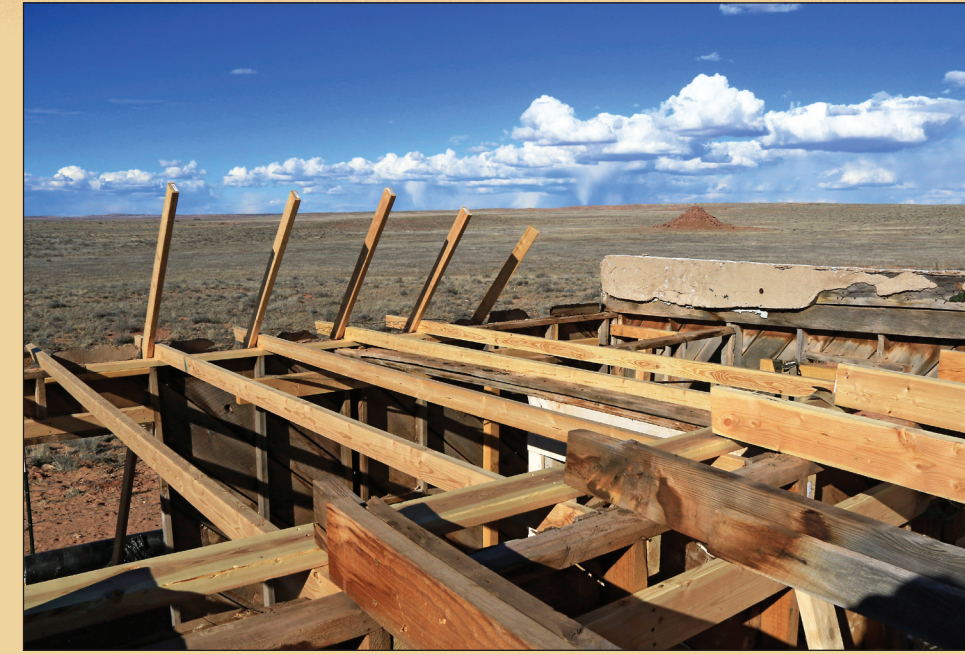
The new roof structure takes shape as joists and rafters are installed. This view is to the northeast.

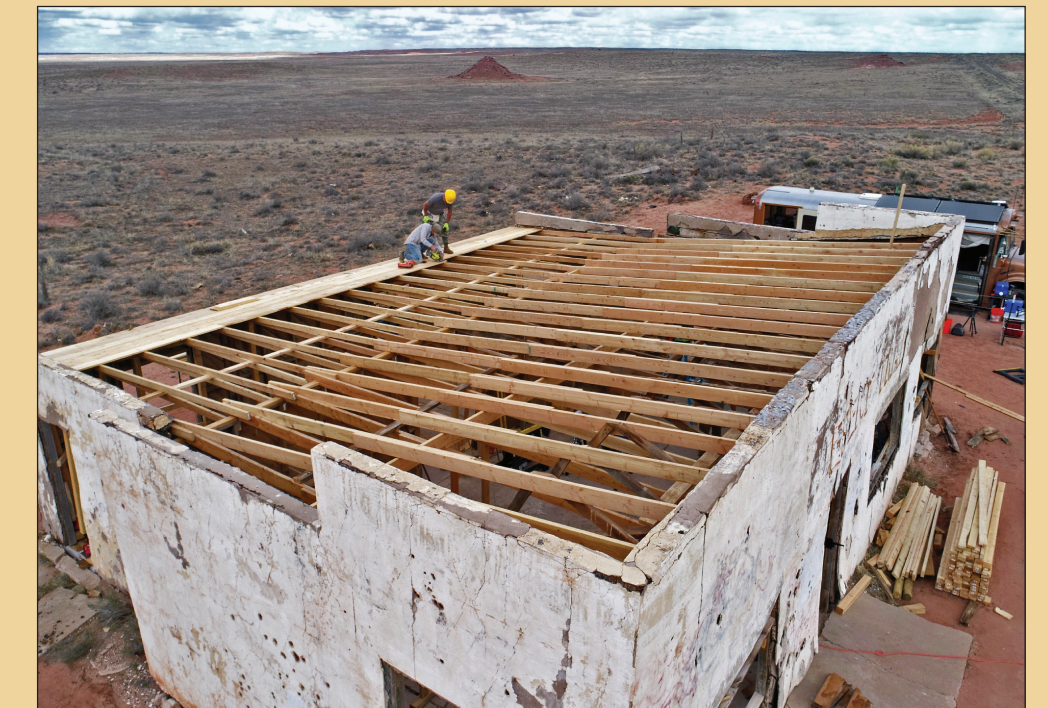
With the roof structure complete, new decking replaces the old.

To match the original "rough sawn" roof decking, the Co-Op located a specialty lumber mill in Albuquerque that could supply the same type of material. Once the decking was applied and covered with a vapor barrier, corrugated steel roof panels similar to the originals were installed and sealed.

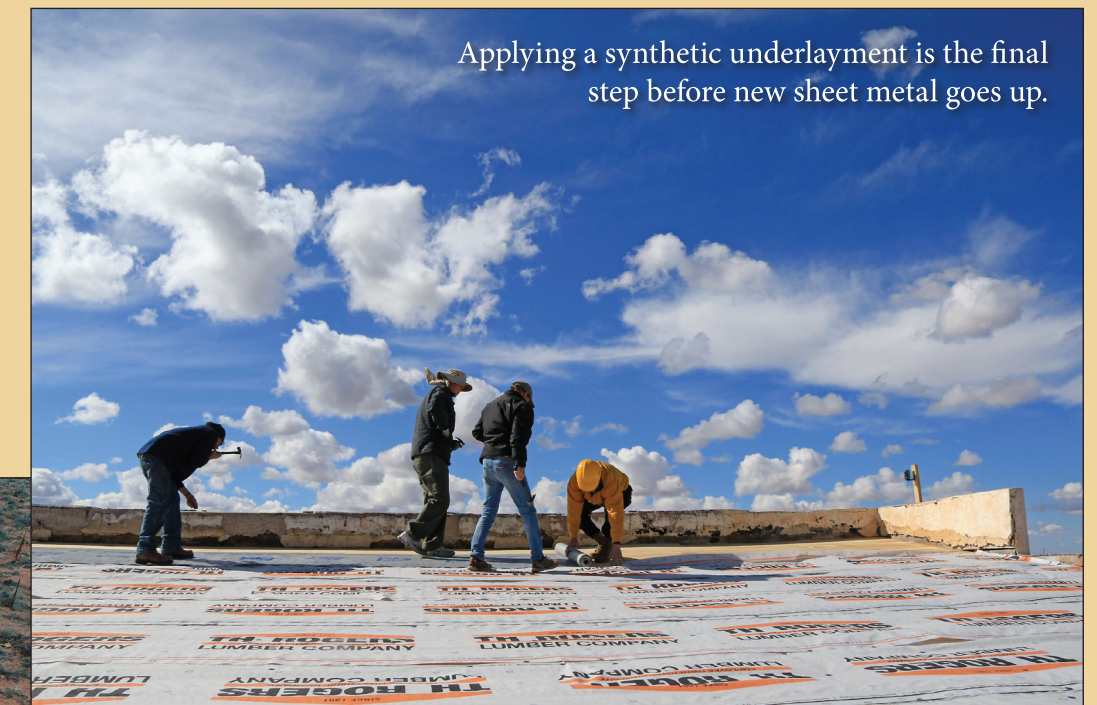
Applying a synthetic underlayment is the final step before new sheet metal goes up.

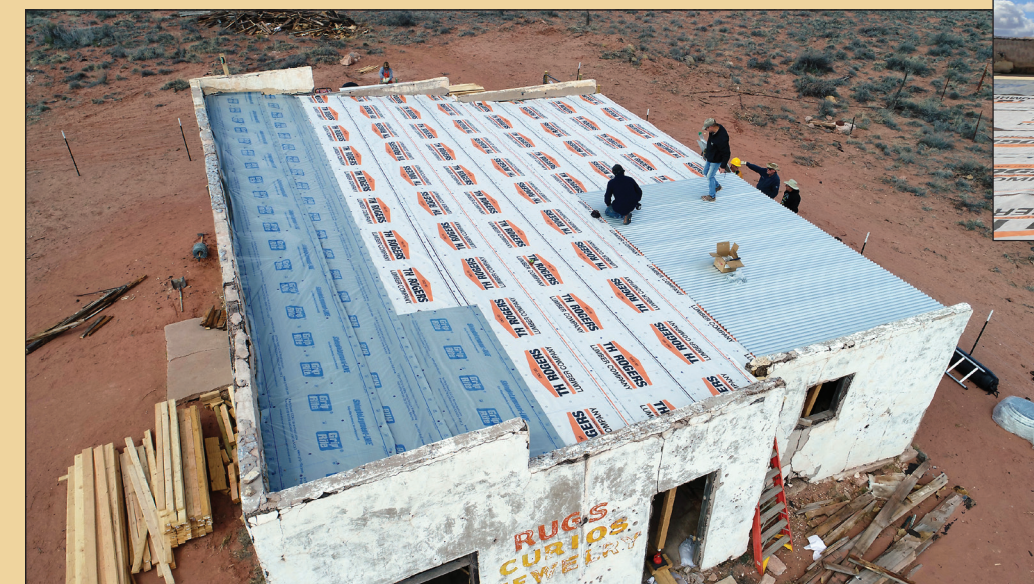
Corrugated panels, similar to the old, will ensure a durable roof for decades to come.

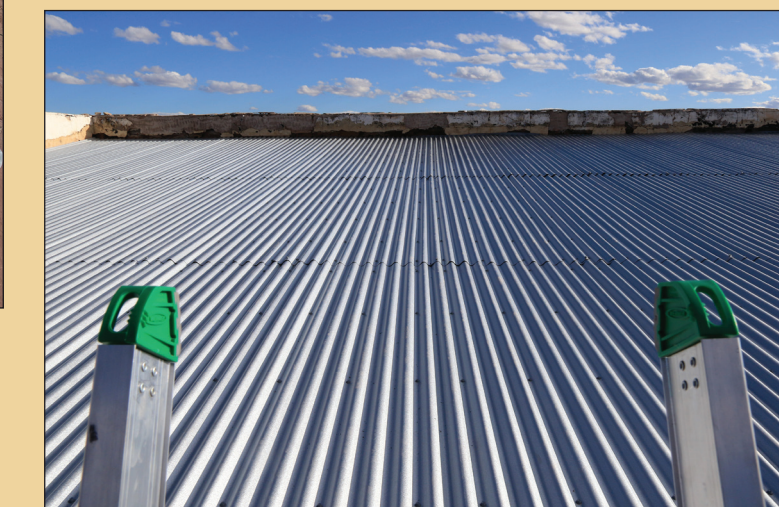
The completed new roof is safe, strong, and ready for duty.
