# Rescue PHASE 3

(MAY 23-29, 2019)

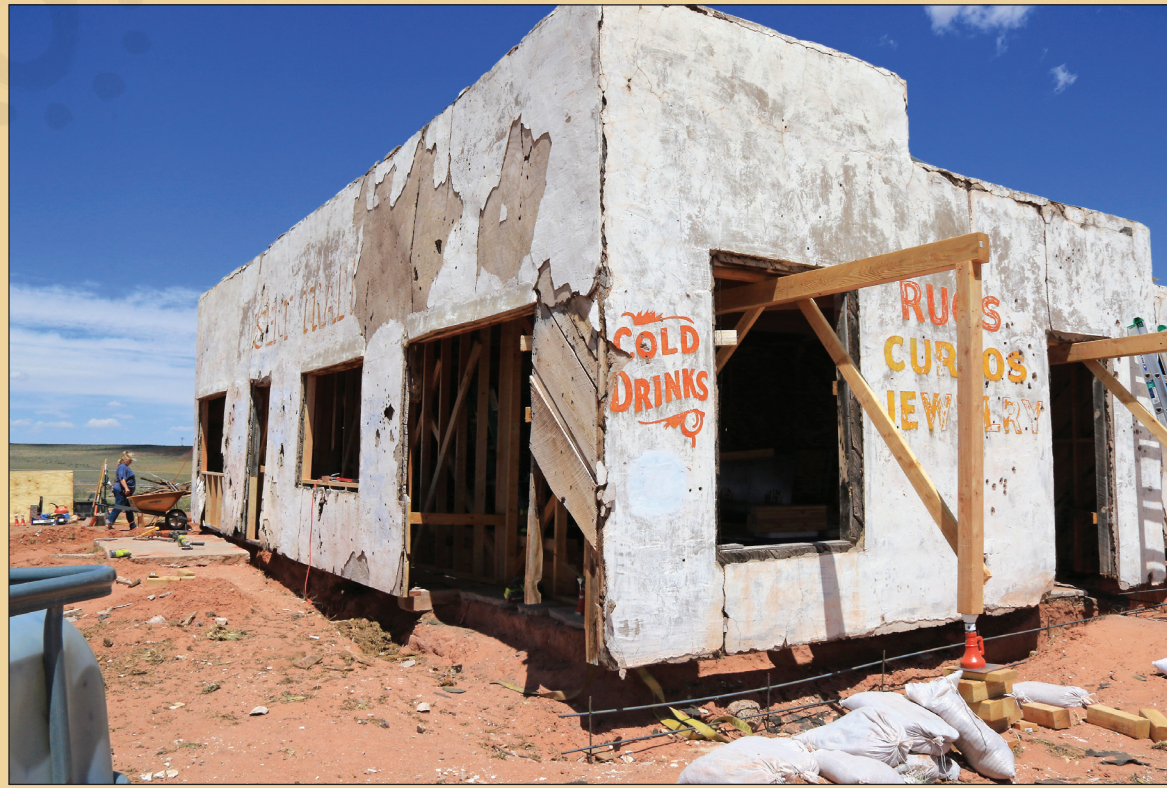
With shear walls on the inside and support beams extending through window and door openings, the trading post is fully levitated.

With the walls elevated and the roof replaced, the trading post was ready for a new foundation. Supported by the shear walls and other bracing, the building was levitated. This allowed for a trench to be dug below the existing exterior walls and a new base plate to be attached to the bottoms of the wall studs, most of which had been "sistered" with new lumber attached to their sides and trimmed to the correct length. The exterior stucco and sheathing were also trimmed to line up with the new base plate, which was now on plane with the top of the concrete floor. This would bring the newly poured concrete to the same elevation as the slab when it reached the bottoms of the walls.

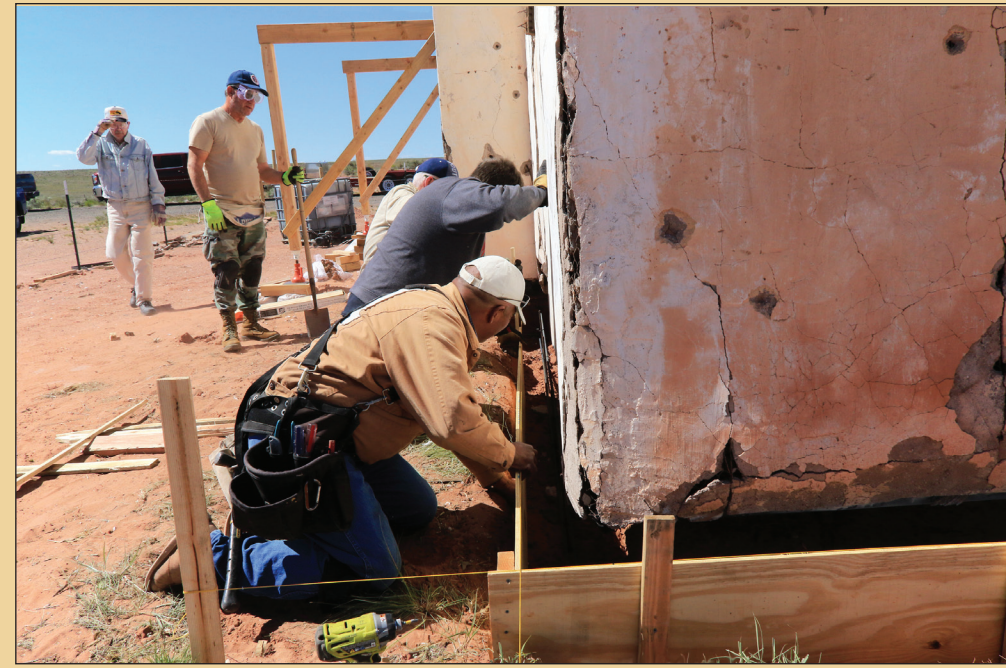
Concrete forms were set at the same height of the building's slab floor.

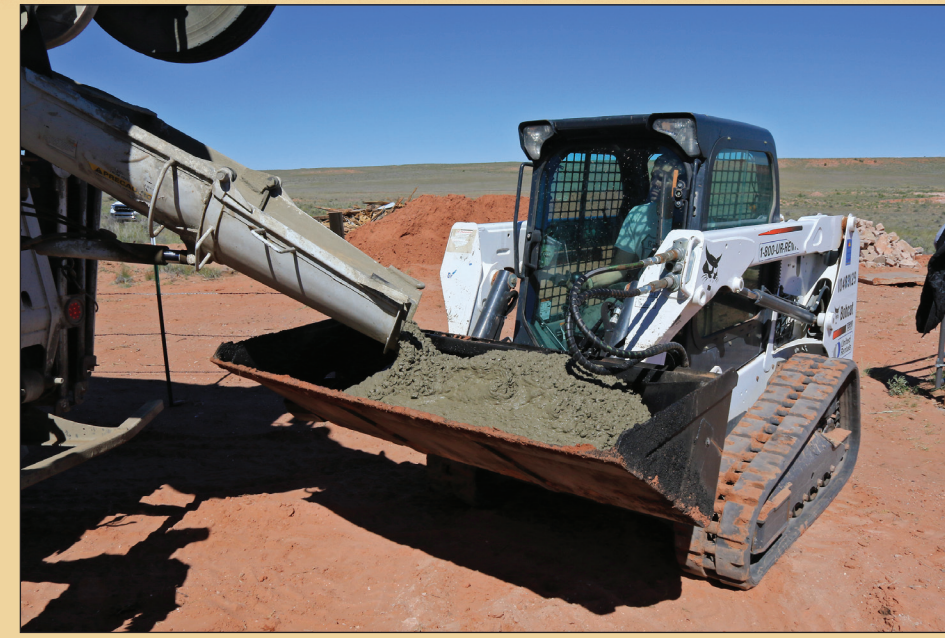
Specialized equipment was used to maneuver the wet concrete.

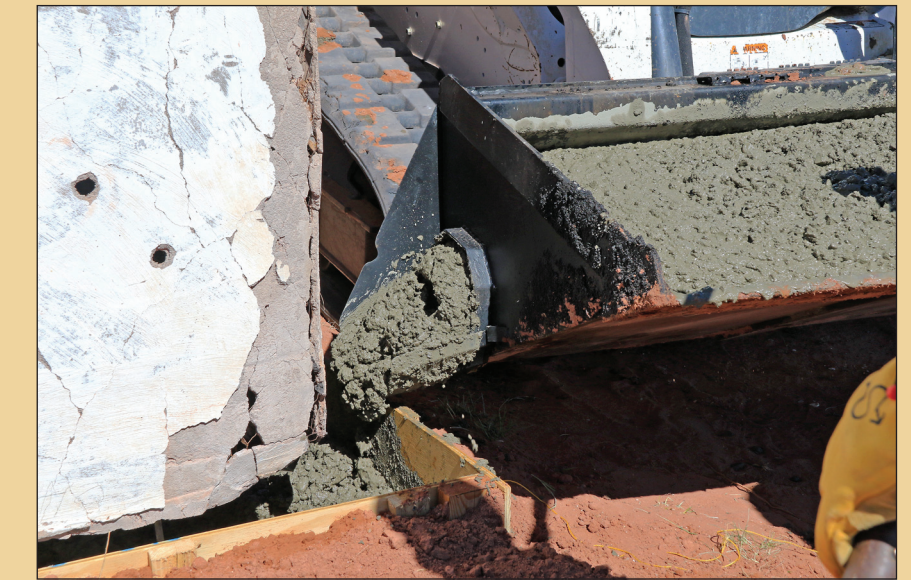
An inventive device created by a Co-Op member allowed for controlled dispensing of concrete into the footing.

Once reinforcing steel bars were installed in the trench and concrete anchors (called J-bolts) were inserted through the base plate at intervals, plywood forms were constructed and braced, completing preparation for the new foundation. Concrete, requiring two trucks, was delivered from sixty miles away in Joseph City, most of it dispensed with an auger-driven bucket that had been designed and built by one of the Co-Op members.

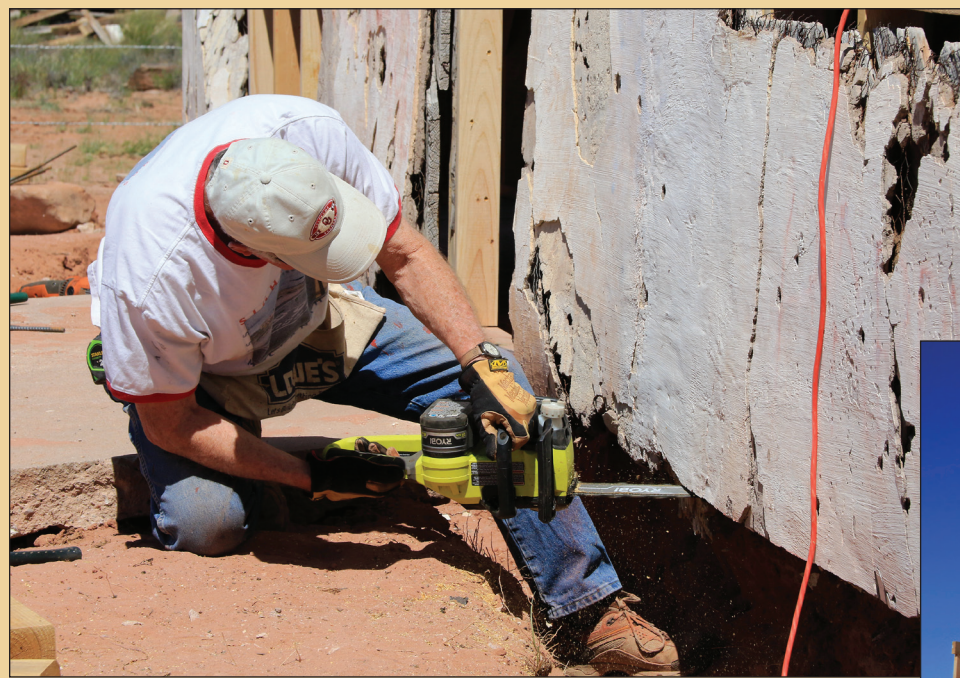
Bottoms of exterior walls were trimmed to match the level of the slab floor inside.

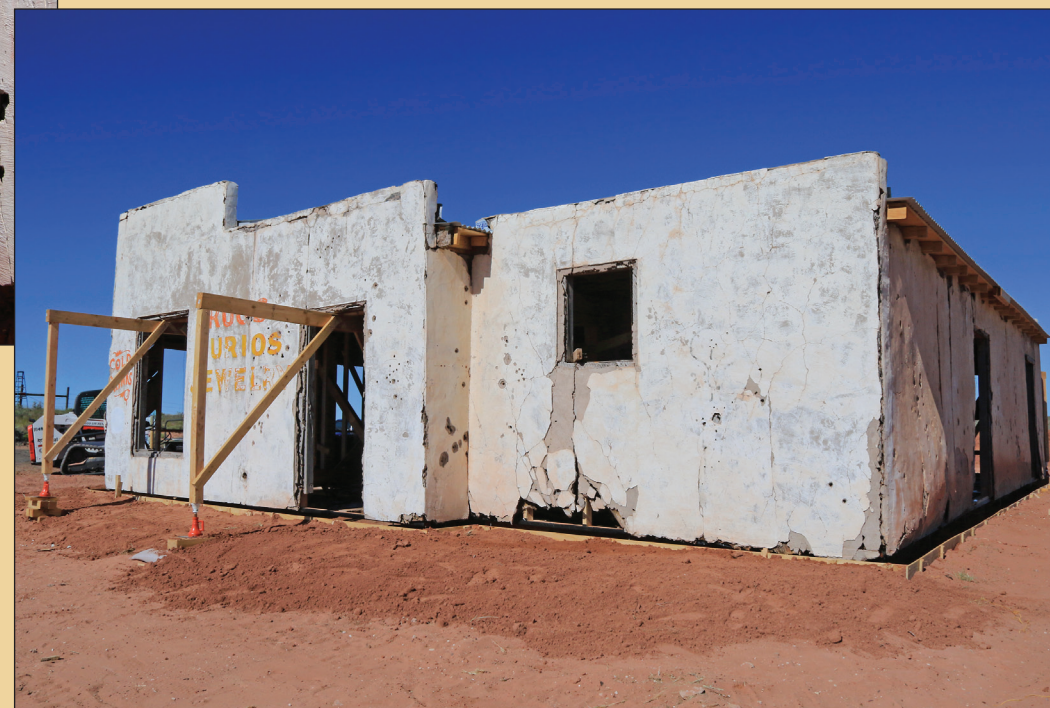
Once set, the concrete forms were backfilled with earth for support.

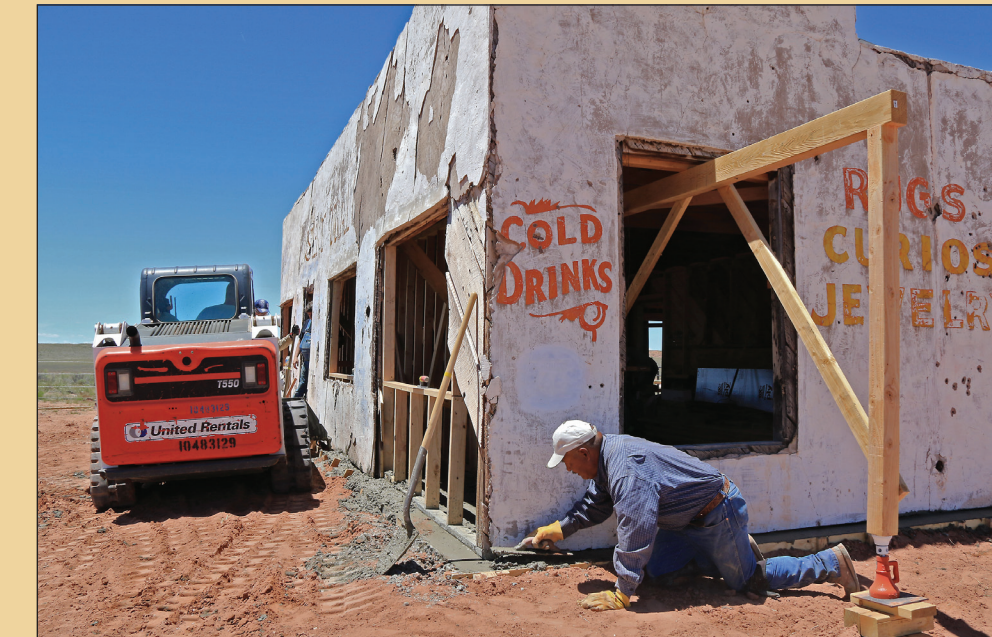
As concrete filled the trench, workers troweled it to a smooth finish.

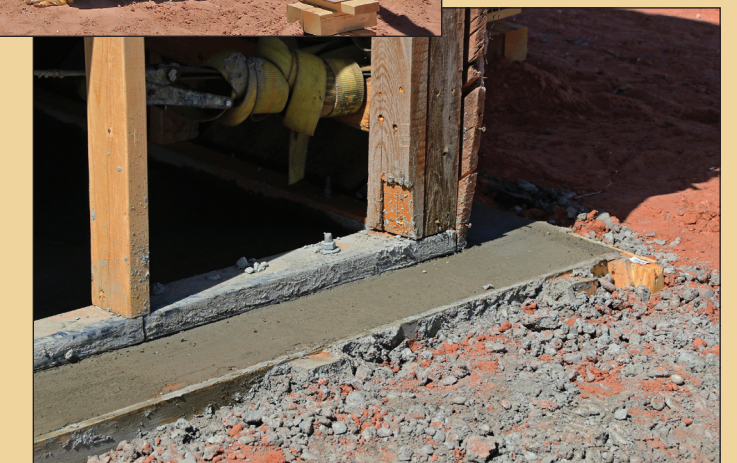
New concrete hardens at a corner of the trading post.

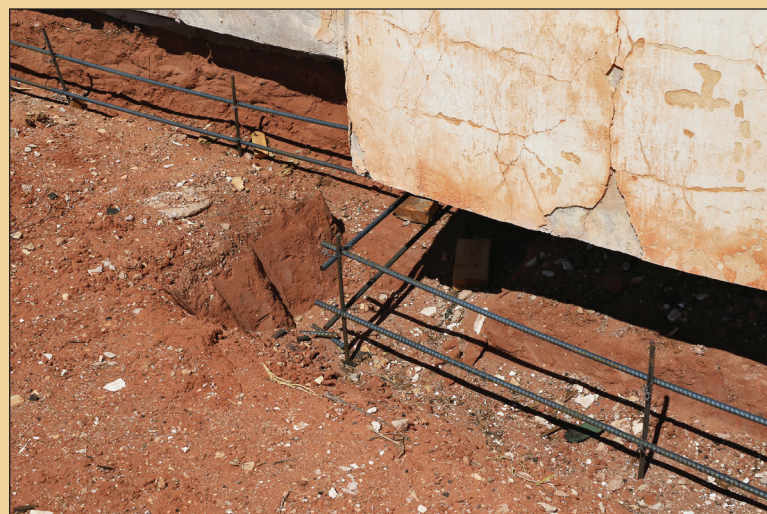
With the foundation trench completed, rebar was placed into the new footing.

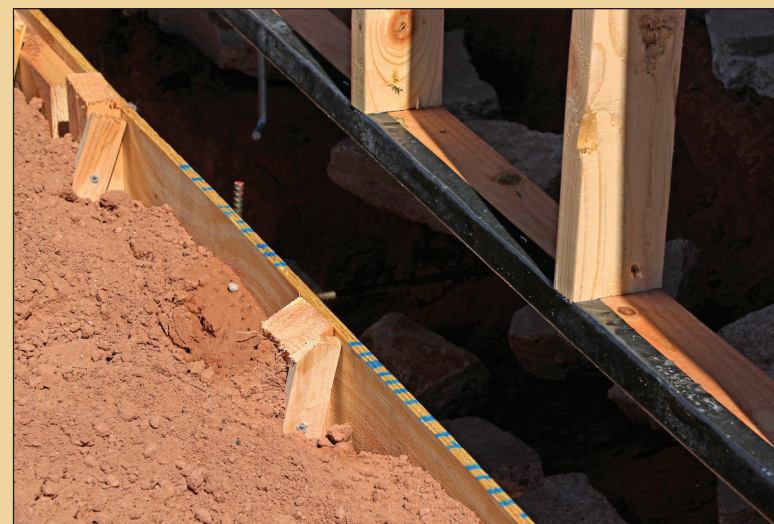
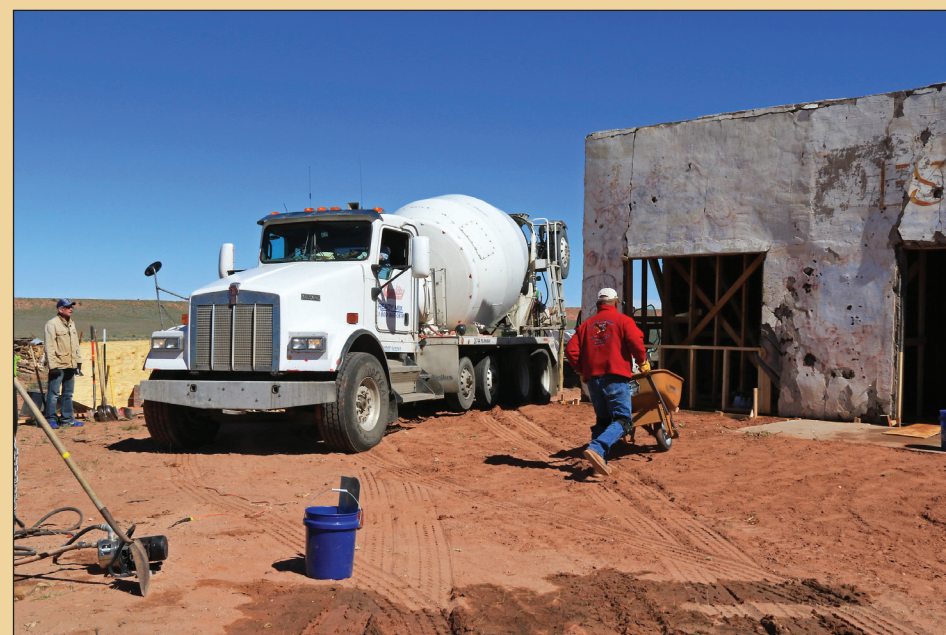
The first truck arrived at 9:00 a.m., signaling the start of a busy day.

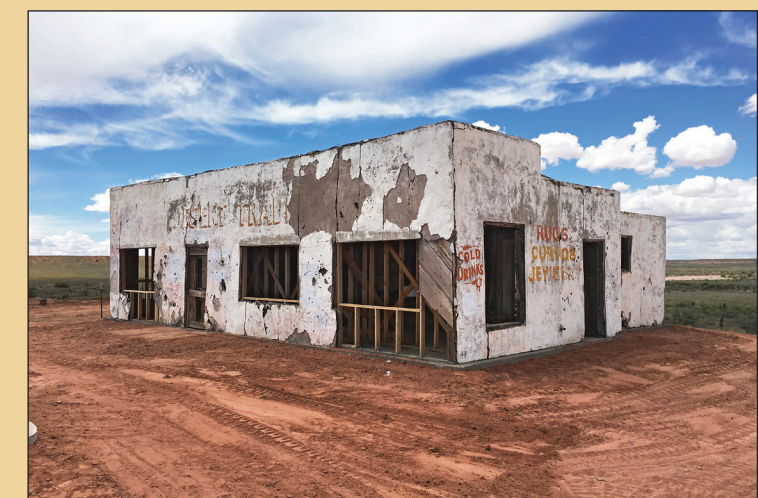
Backfilling and grading of the landscape brought the third phase to a close.

After being troweled smooth and left to set up overnight, concrete forms and temporary bracing were removed, and the landscape re-shaped for proper drainage.
