the rise, fall & rise

of the pdtp.

Written and Compiled by Jim Ross

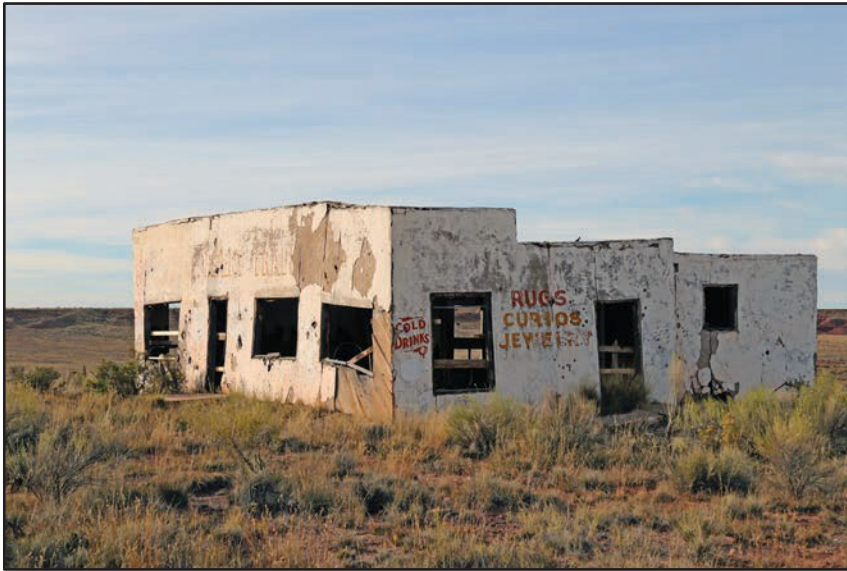
Slumped and bowed walls, a disintegrating foundation, and a rotted roof had brought the trading post to the brink of collapse.

The roof, far beyond repair, would have to be completely rebuilt.

In their NPS grant application, the Co-Op proposed an ambitious approach to stabilizing the building, which would be done in three phases: 1) raise and straighten the walls; 2) completely replace the roof structure; and 3) install a new foundation.

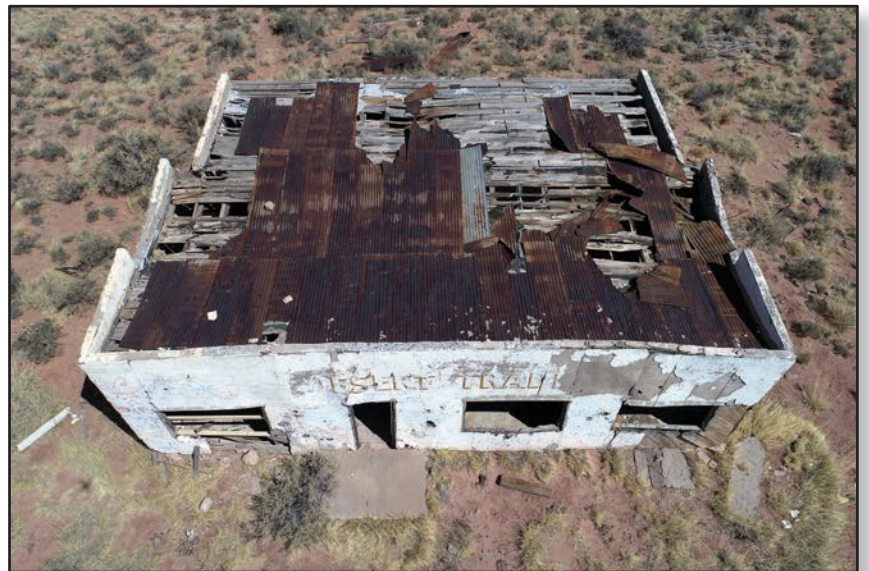
Exposed rafter tails had decayed and window openings were skewed.

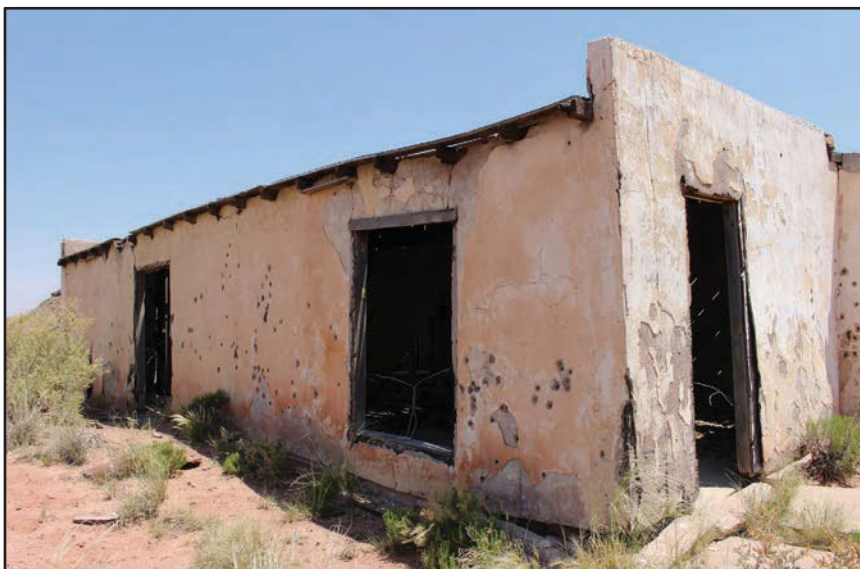
The bottom of the east wall had been pushed out roughly 8" due to the crumbling foundation.

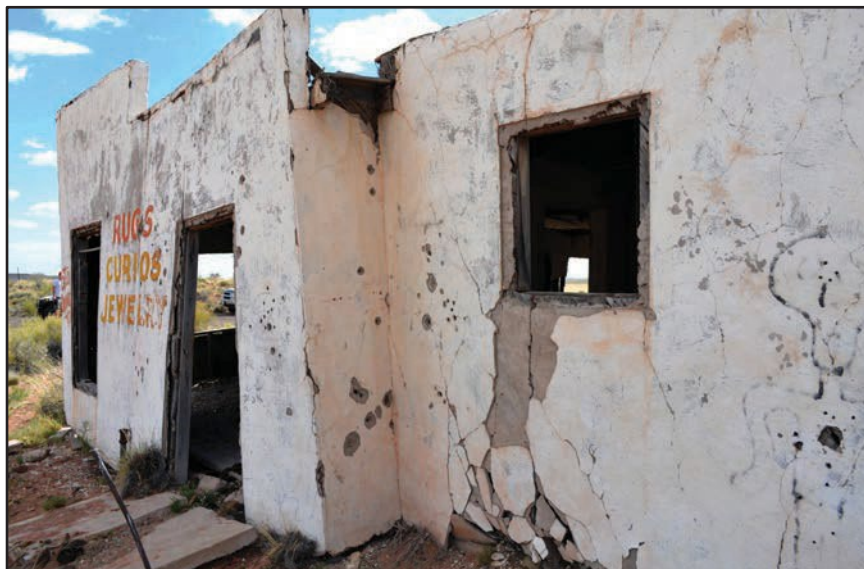
The foundation had completely pulled away from the building's northwest corner.

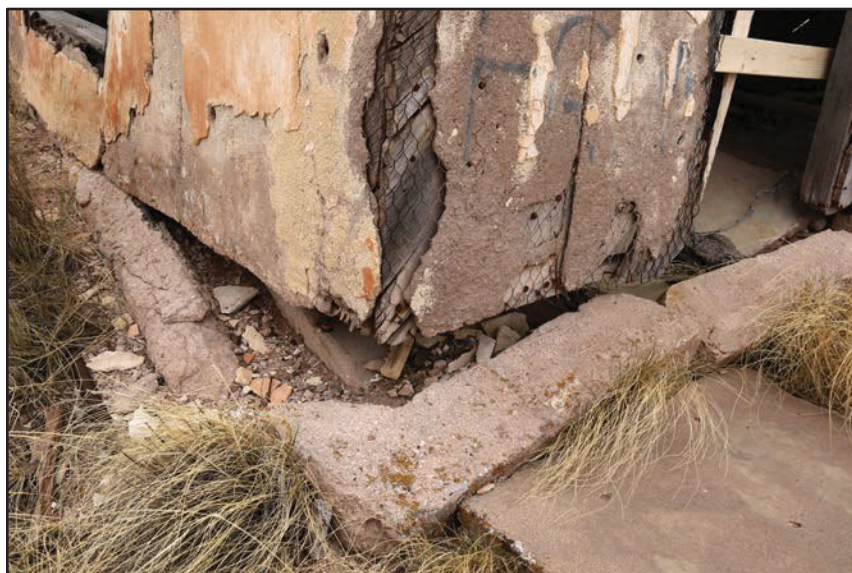
Damage done by cattle had caused large sections of stucco to fall away.

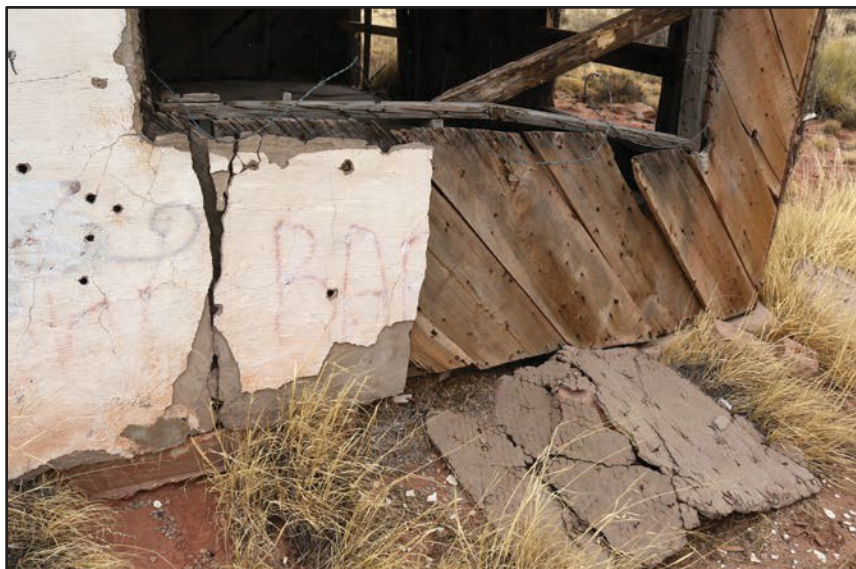
Very little support remained at the northeast corner.

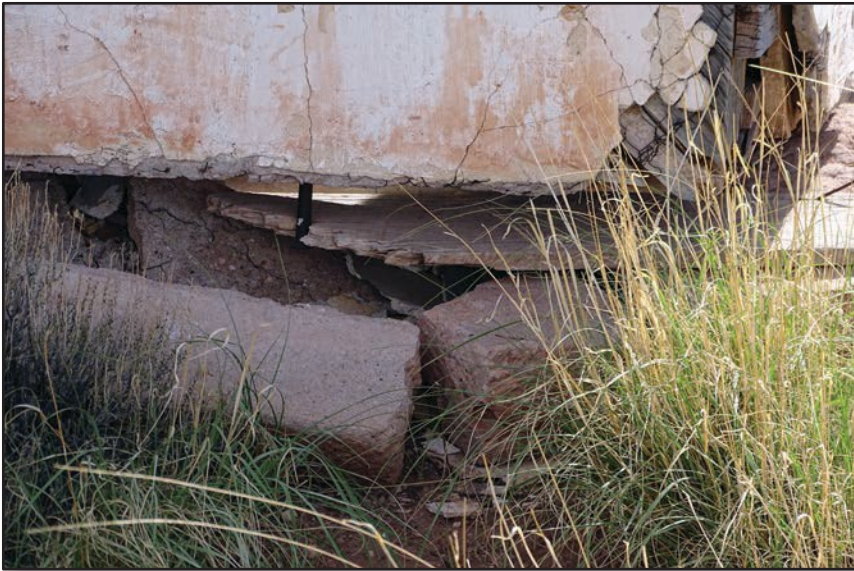
Cattle had destroyed the wall and window opening to the left of the front door.

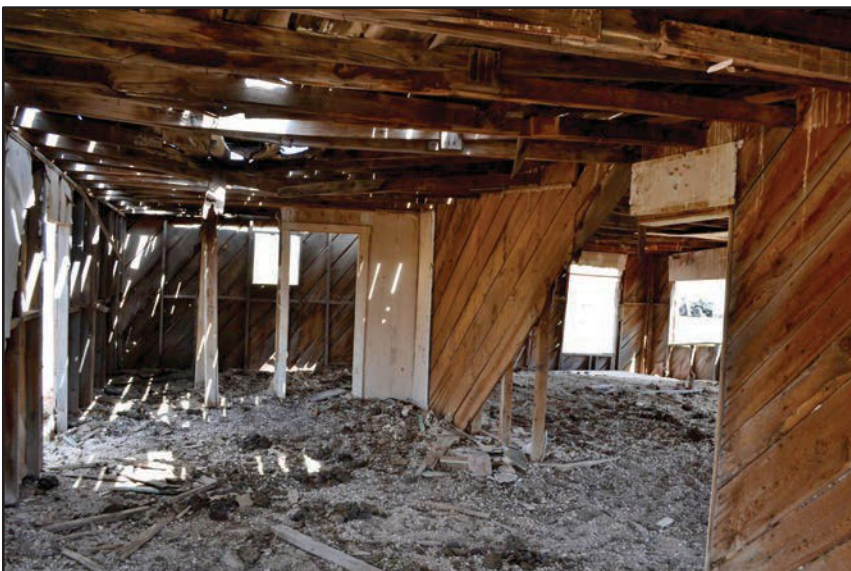
The worst structural damage was at the southeast corner, where the collapsing foundation had caused the walls to drop 16" below the level of the concrete slab.

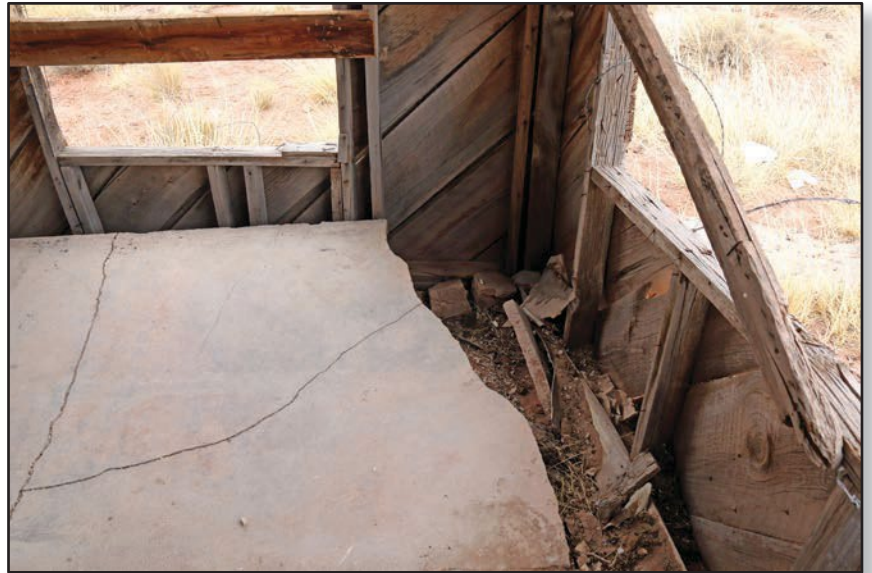
Interior view of the building's northwest corner.

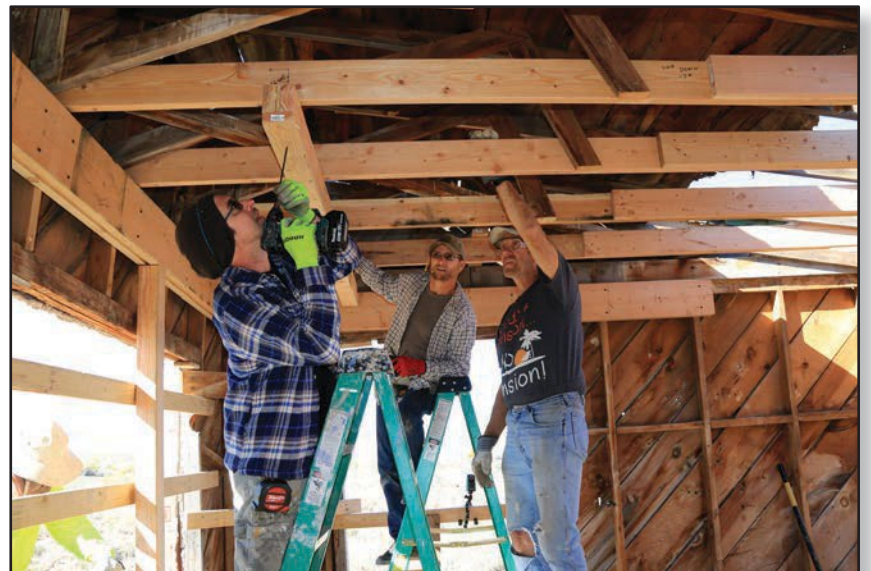
Jackposts and screw jacks used to lift the southwest corner are put in place.

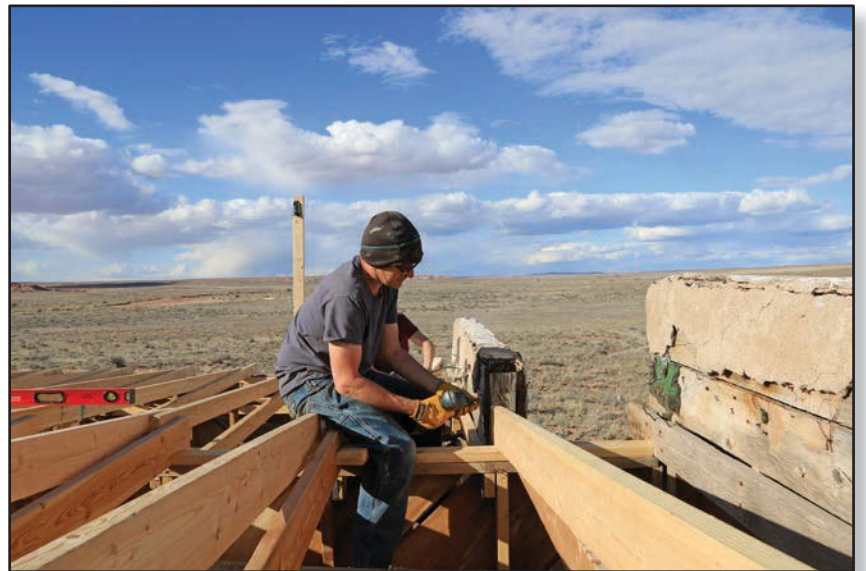
New ceiling joists are assembled as old ones come down.

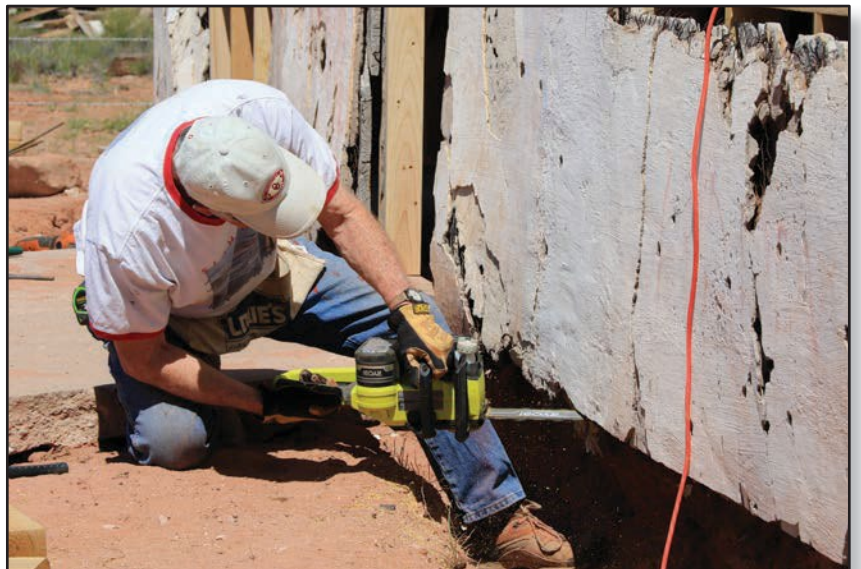
Sheathing and stucco is trimmed to allow for a new sill plate on the bottoms of the walls.

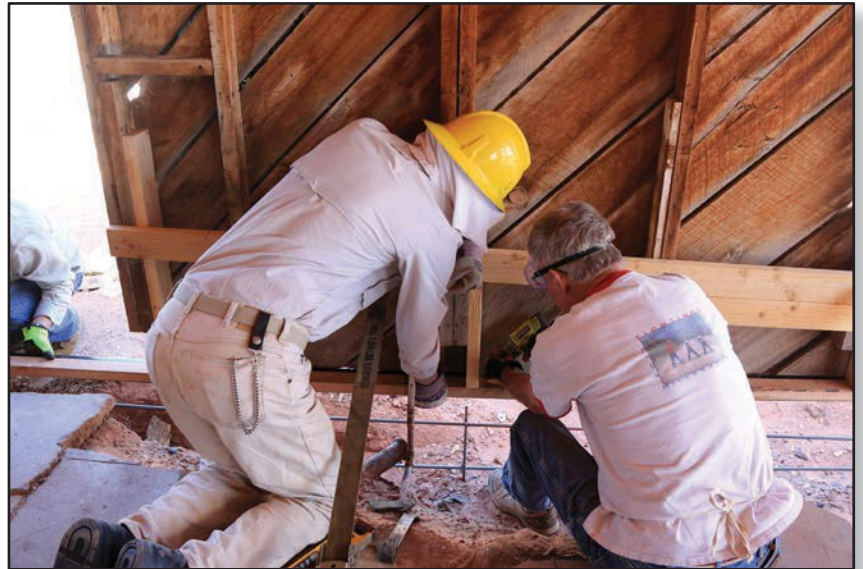
A new sill plate is attached to the bottoms of the walls.

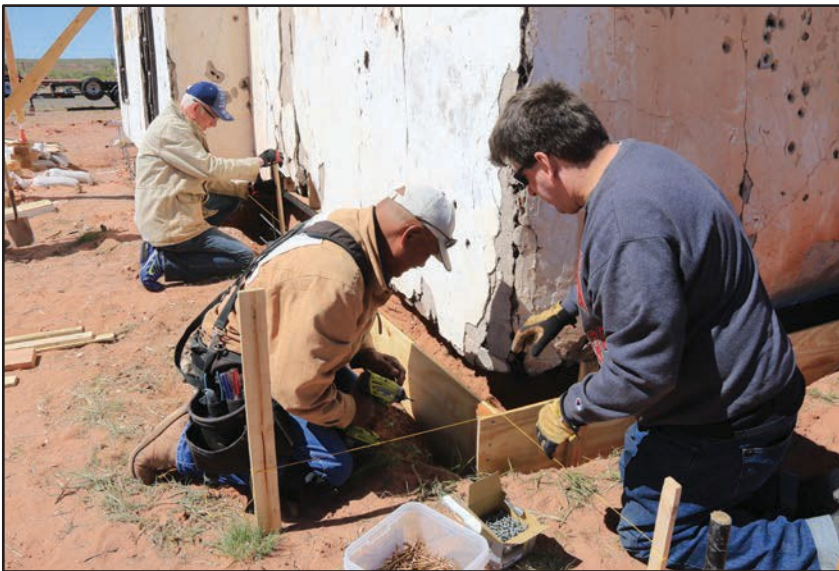
Mark Norman, Gene Shepherd, and Scott Wallace install concrete forms.

Foundation forms were backfilled with earth for support.

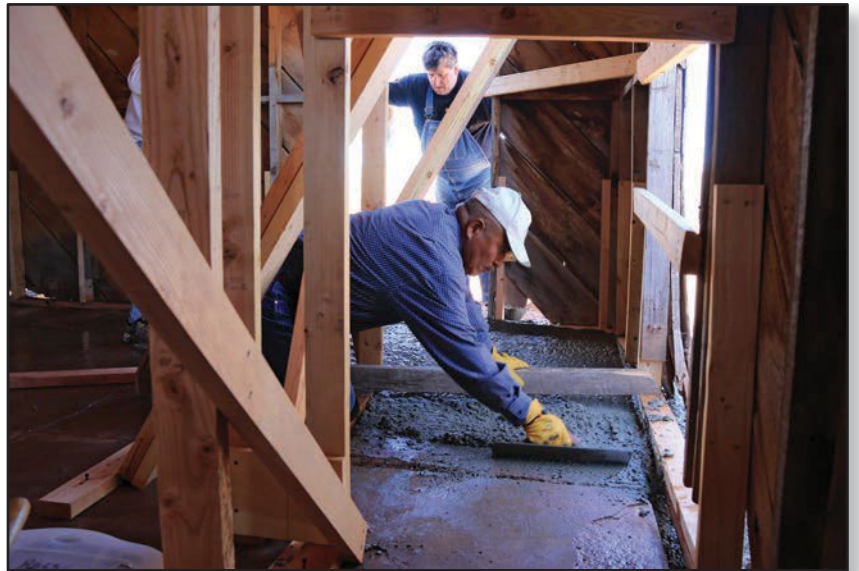
A bucket and auger designed by Co-Op member Rich Dinkela makes dispensing concrete efficient.

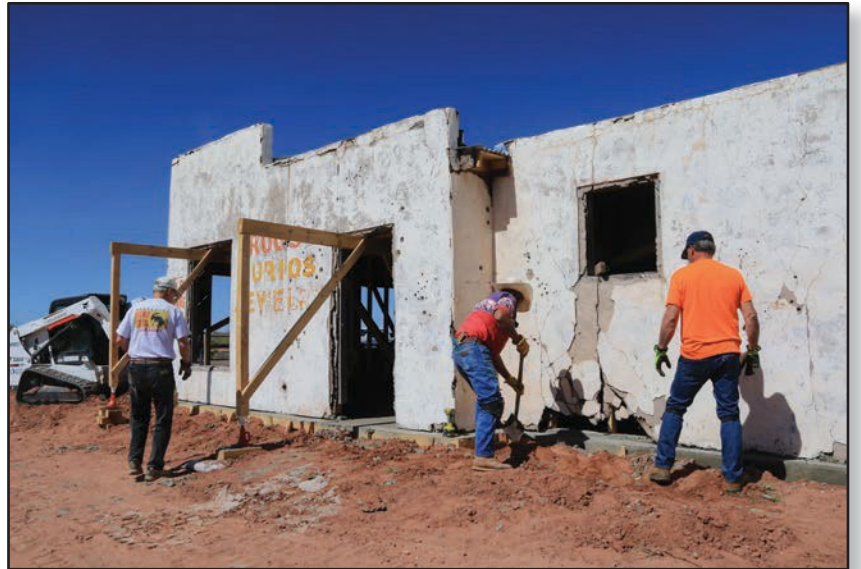
Forms are removed from the hardened concrete.

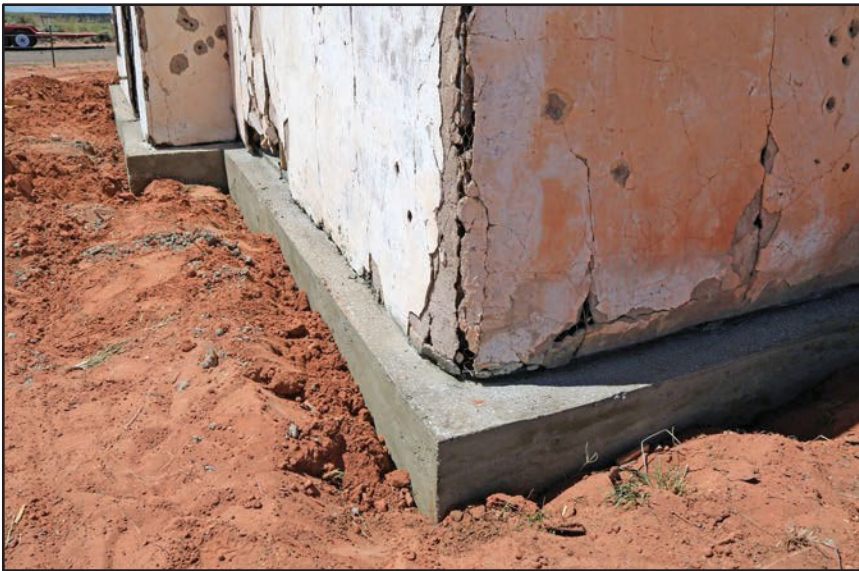
The trading post now sits on a reinforced foundation.

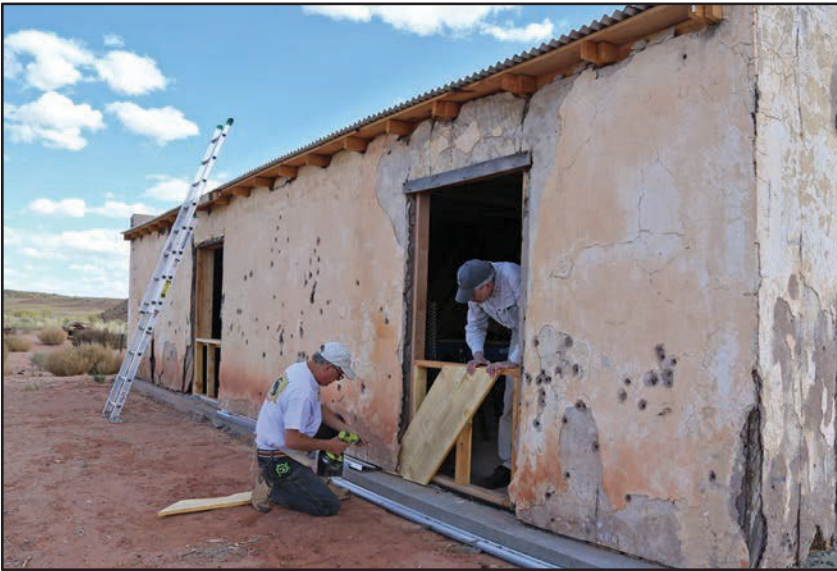
Sheathing is replaced under the rear windows.

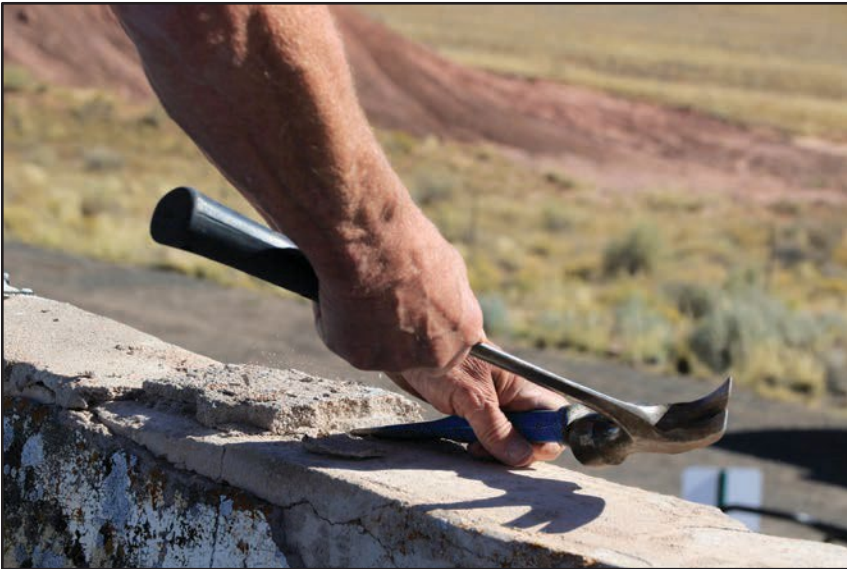
The parapet walls required labor intensive prep for stucco repair and capping.
