racing imminent collapse when

acquired in early 2018 by the Route

66 Co-Op, a U.S. Park Service grant with contracting and preservation and other fundraising efforts allowed experience, along with other relevant stabilization work of the trading post skill sets, but no one involved had attempted such a challenge. The budget discouraged hiring the work done, recades of soil erosion, wind, and but networking led to other preservawater had opened the roof and tionists who had made careers of savcaused the walls to sag from a dising similarly distressed landmarks. integrating foundation, which was Consultations with them generated the nothing more than a concrete curb knowledge needed to produce both sitting on the ground. Roof rafters were confidence and a plan, although rotted, and exterior walls had been improvisation proved to be a daily damaged by cattle. The site's remote ingredient once work got underway. location created logistical challenges, requiring that a generator and water With few exceptions, the rescue was completed by a spirited crew of allbe brought in, and that equipment and materials be transported from volunteer labor, and a successful Albuquerque and Gallup, Ne

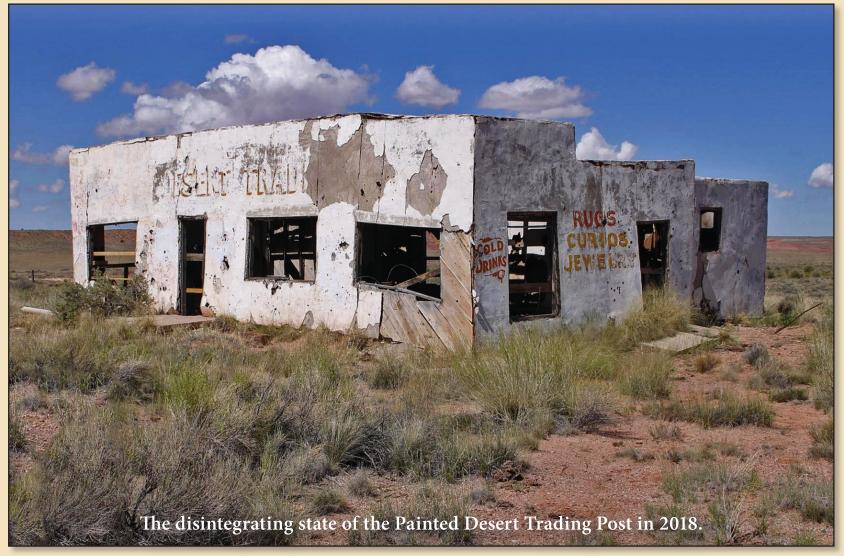
The building's roof sagged from decades of unchecked wind, rain and snow.

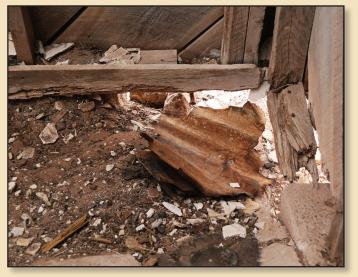
The southeast corner had slumped a full sixteen inches from the level of the slab floor, creating a serious threat to the structure's stability.
